# 1995 Annual Report

RE: Flambeau Mining Company - 1995 Annual Report

FLAMBEAU MINING COMPANY  
1995 ANNUAL REPORT

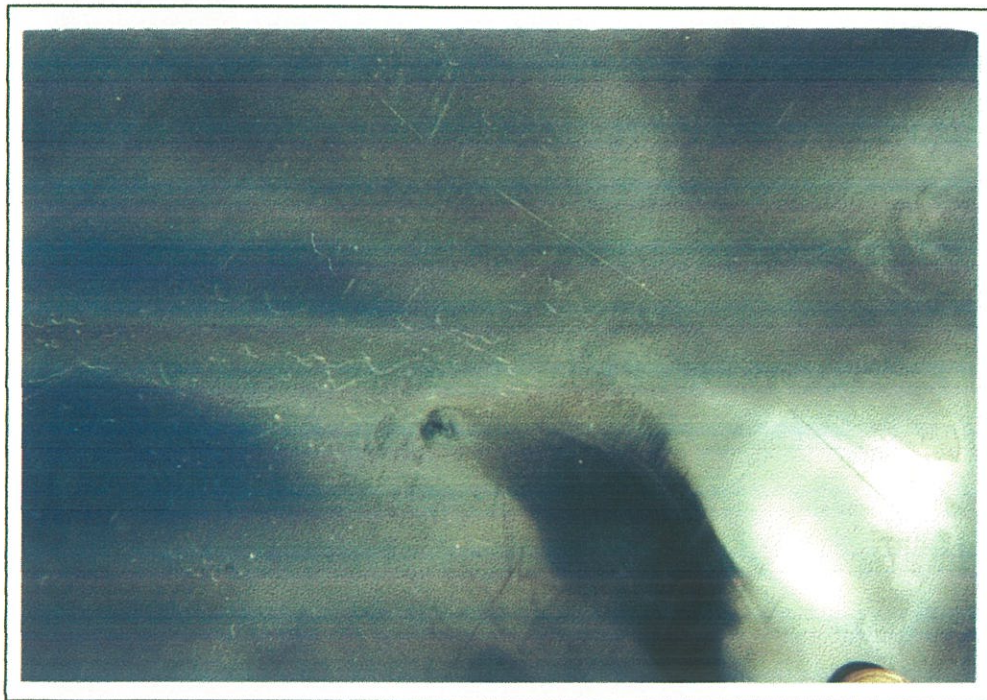
RUNOFF POND HDPE LINER  
INDENTATION

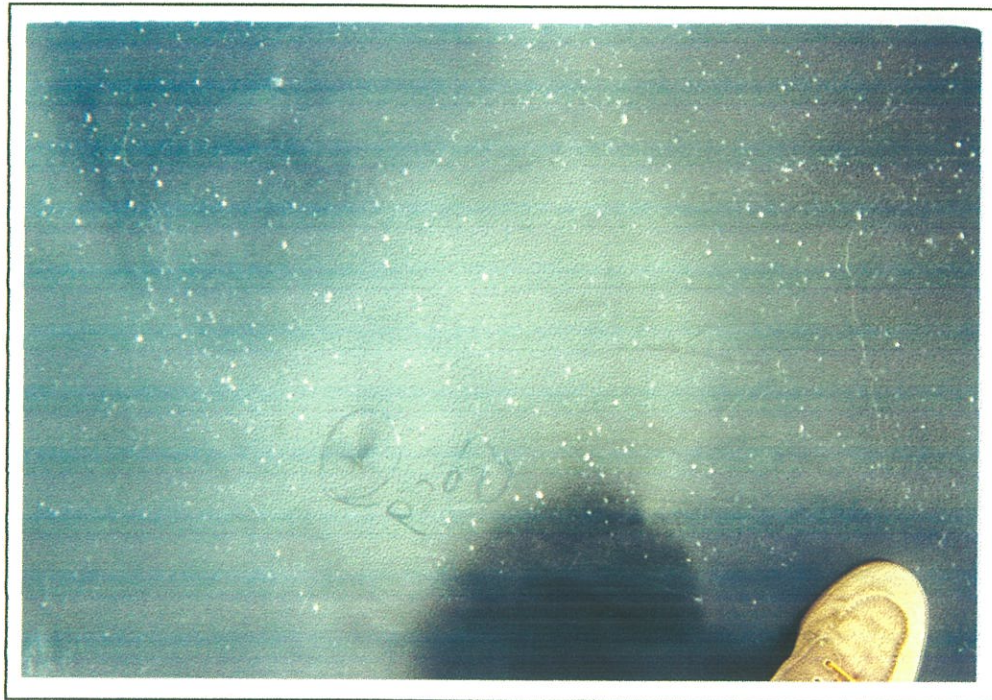
SURGE POND HDPE LINER  
INDENTATION

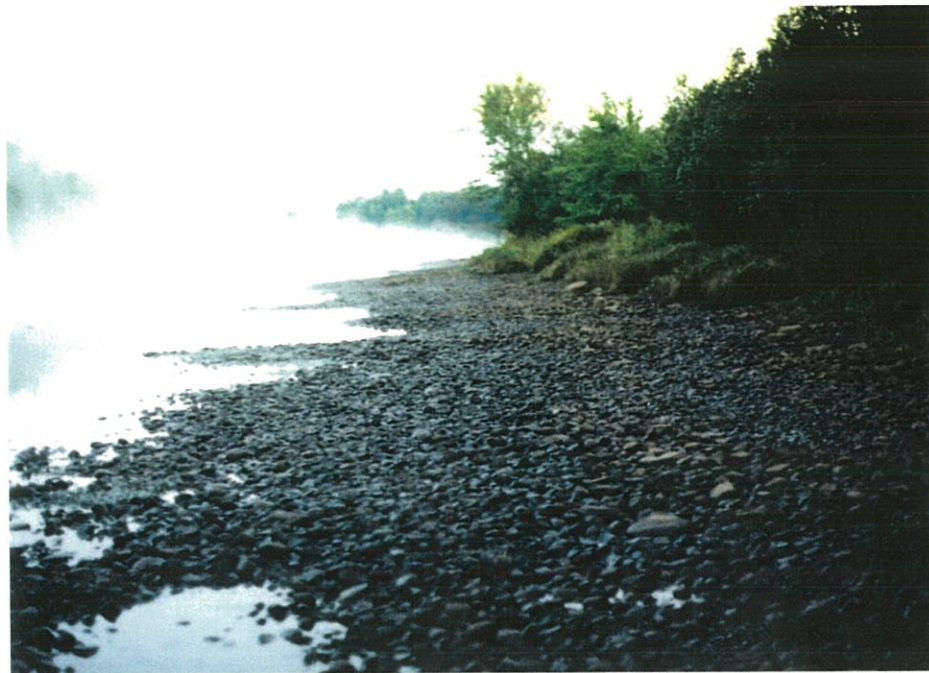
Photograph 1 September 1995  
Flambeau River near Blackberry Lane (6:30 a.m.) depicting extent  
of river low flow condition experienced overnight.

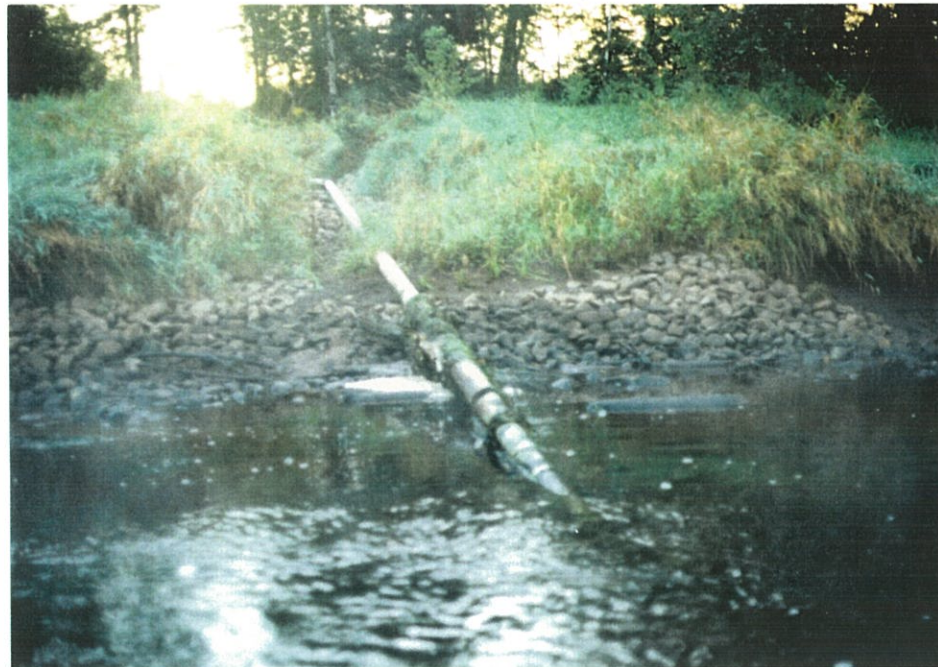
Photograph 2 September 1995  
Mine discharge channel outfall 002 with temporary intake pipe for  
hydic soil recharge and emergency dust suppression in-place.

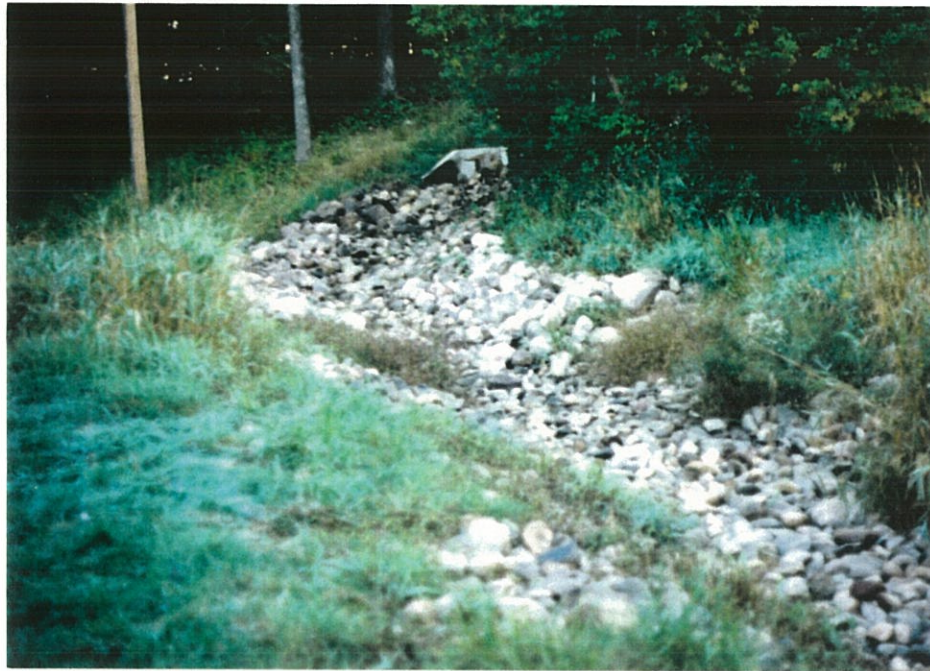
During 1994 a beaver hut had been observed upstream from Outfall 002. Remnants of the beaver hut remain with deposition of sediment observable immediately downstream. There was no sign of sedimentation on the riprap of either Outfall 001 or 002 which could be associated with discharges.

Photograph 3 September 1995  
Outfall 001 showing no signs of deposition of sediments from the discharge of treated effluent.

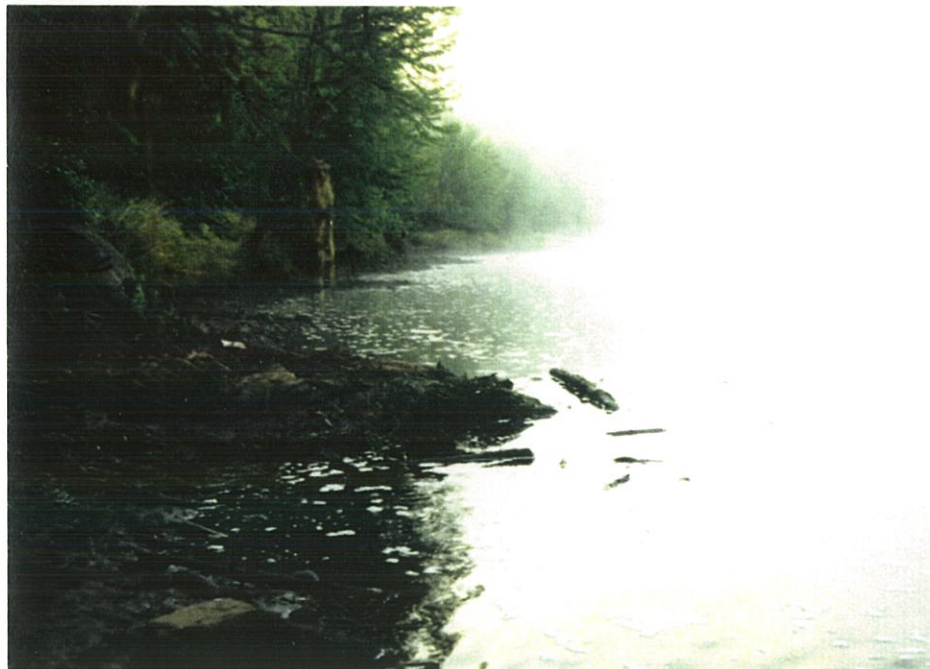
A new beaver hut was observed on shore upstream from Meadowbrook Creek. Slight deposition of sediment was observed in the vicinity of the hut. Downstream from Meadowbrook Creek a bed of *Elodea sp.* had been observed in the past. No *Elodea sp.* was observed at this location during 1995 and was likely eliminated by the flood during September 1994. Additional detail including photographs is provided in Appendix G of this report.

Photograph 4 September 1995  
Flambeau River upstream of Meadowbrook Creek showing remnants of beaver hut.

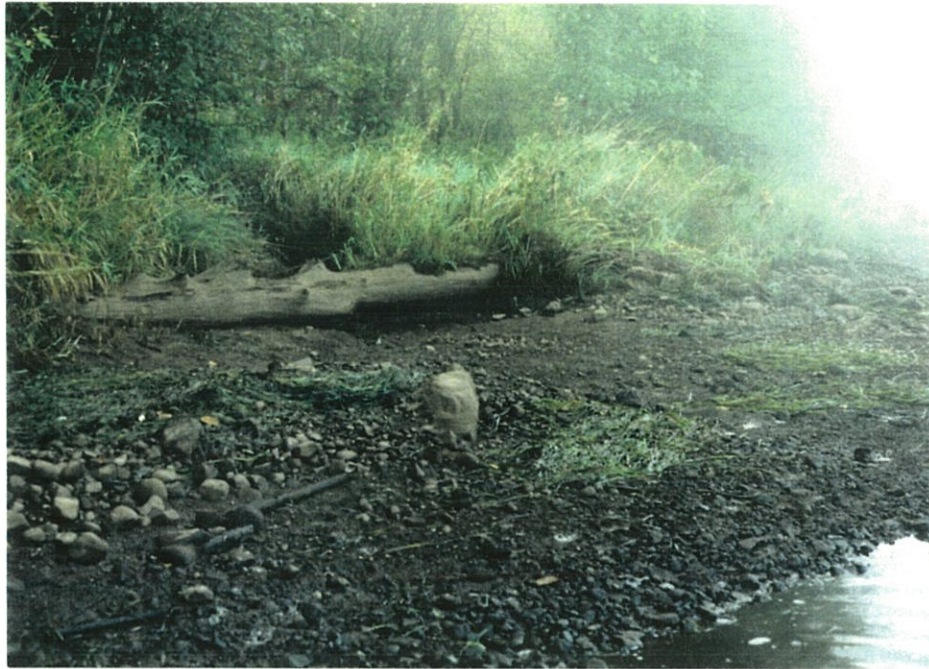
Photograph 5 September 1995  
Flambeau River at the point of discharge of Stream C. Low river stage shows exposed stream bed at the confluence.

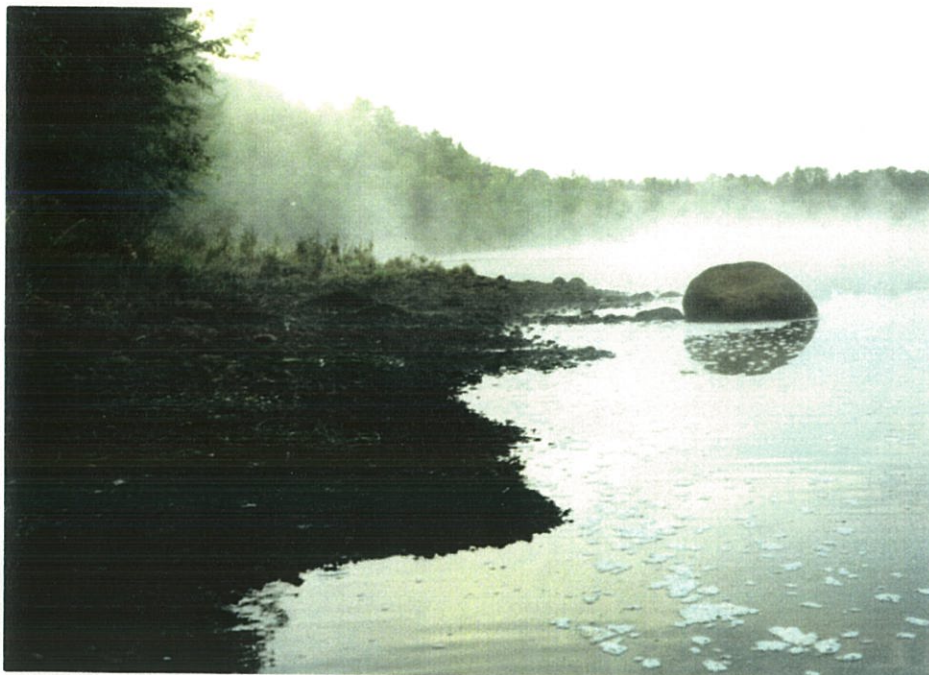
Photograph 6 September 1995  
Flambeau River immediately upstream of Meadowbrook Creek. The area between the large rock and shore is the normal location for small macroinvertebrate.

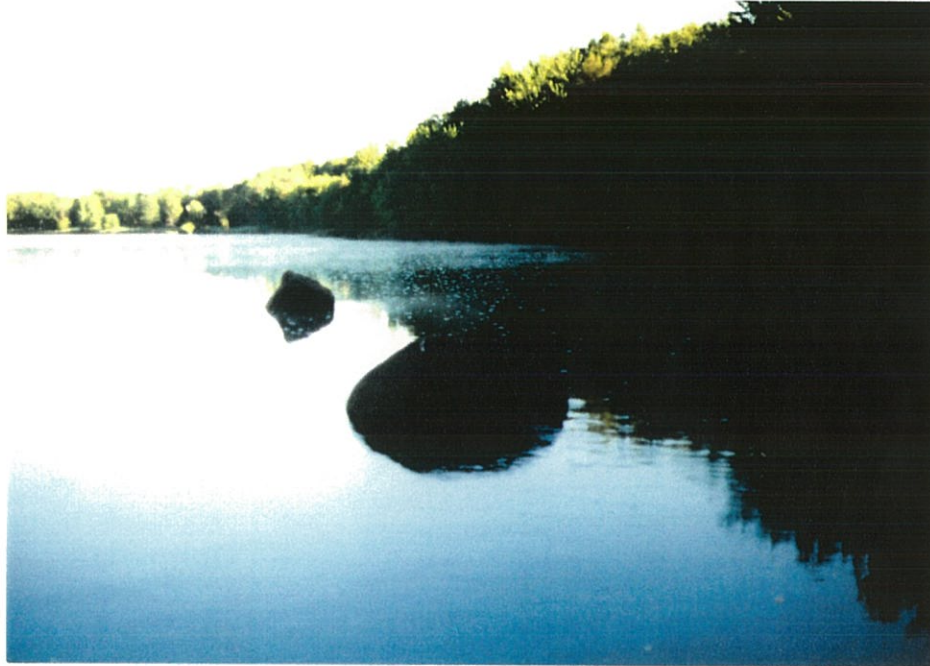
Photograph 7 September 1995  
Flambeau River immediately upstream of Meadowbrook Creek with macroinvertebrate sampling area re-submerged (area from round rock to shore).

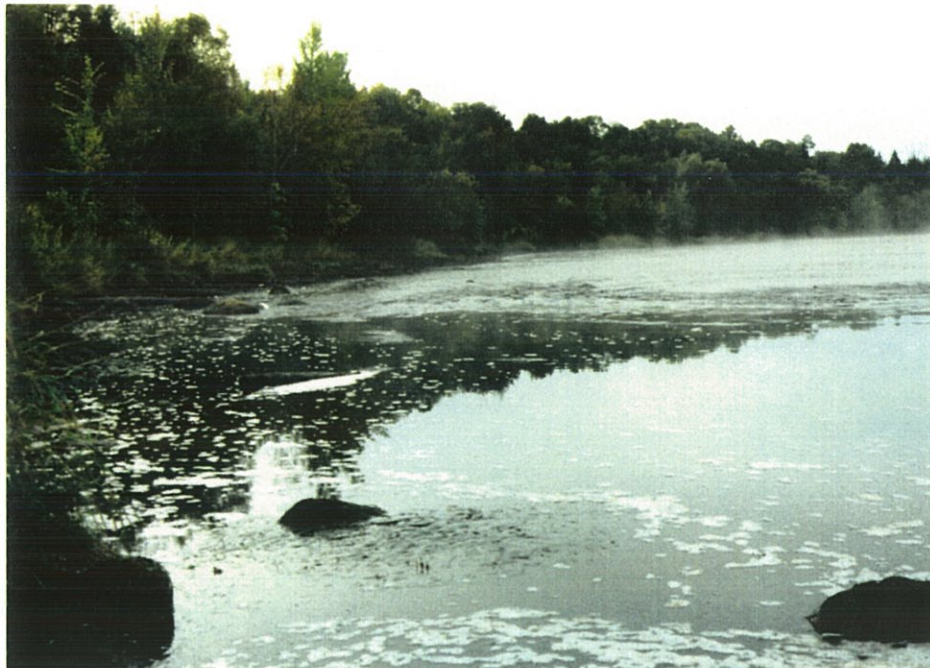
Photograph 8 September 1995  
Flambeau River at pipeline crossing. Exposed riffle area and rocks are normally submerged.

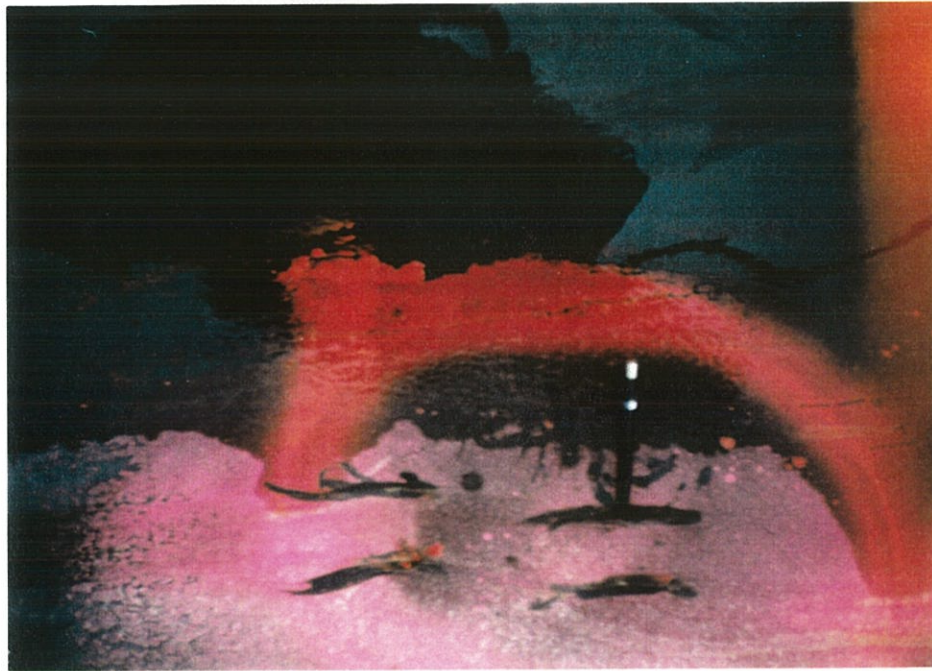
Photograph 1

Location: Surge Pond Liner-Repair  
Description: Puncture No. SP-1

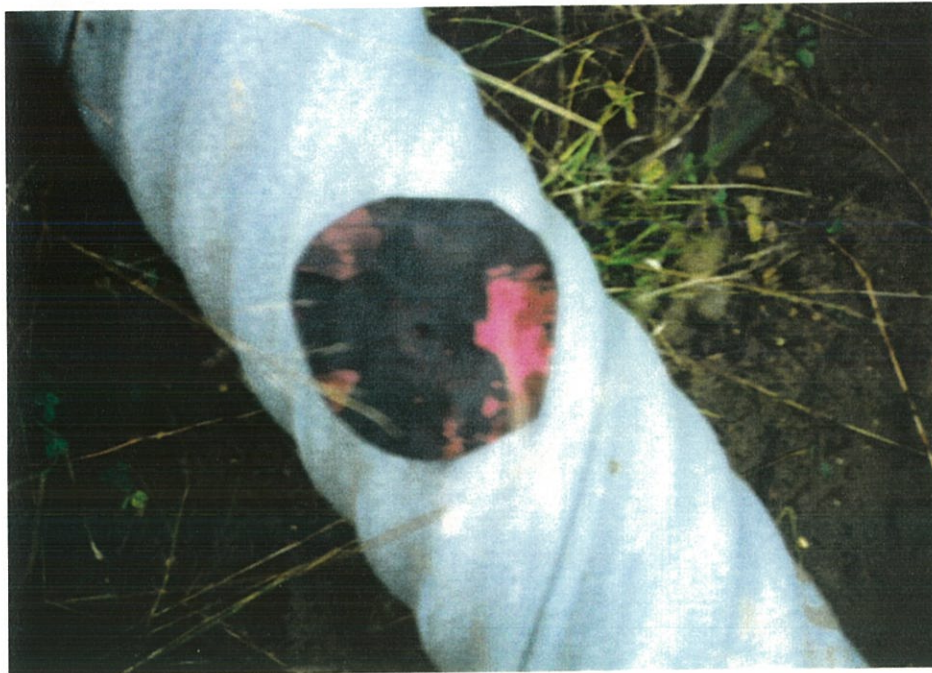
Photograph 2

Location: Surge Pond Liner-Repair  
Description: Puncture No. SP2 (after removal). Note: HDPE cut out containing the puncture was placed on a light colored pipe for photographing.

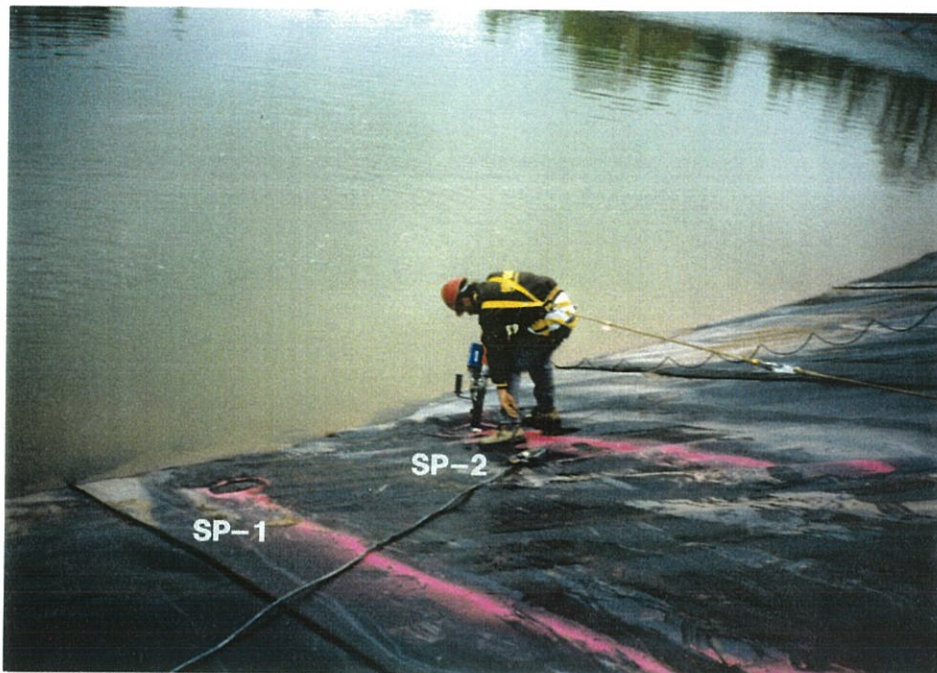
Photograph 3 October 9, 1995  
Location: Surge Pond Liner-Repair  
Description: Extrusion welding repair SP-2

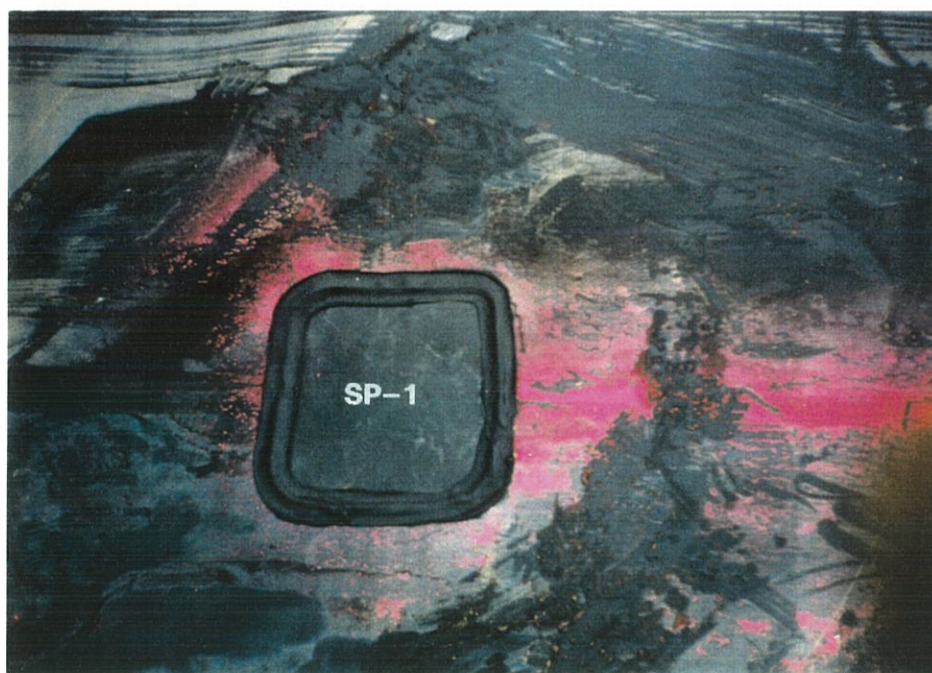
Photograph 4 October 9, 1995  
Location: Surge Pond Liner-Repair  
Description: Repaired Puncture SP-1.

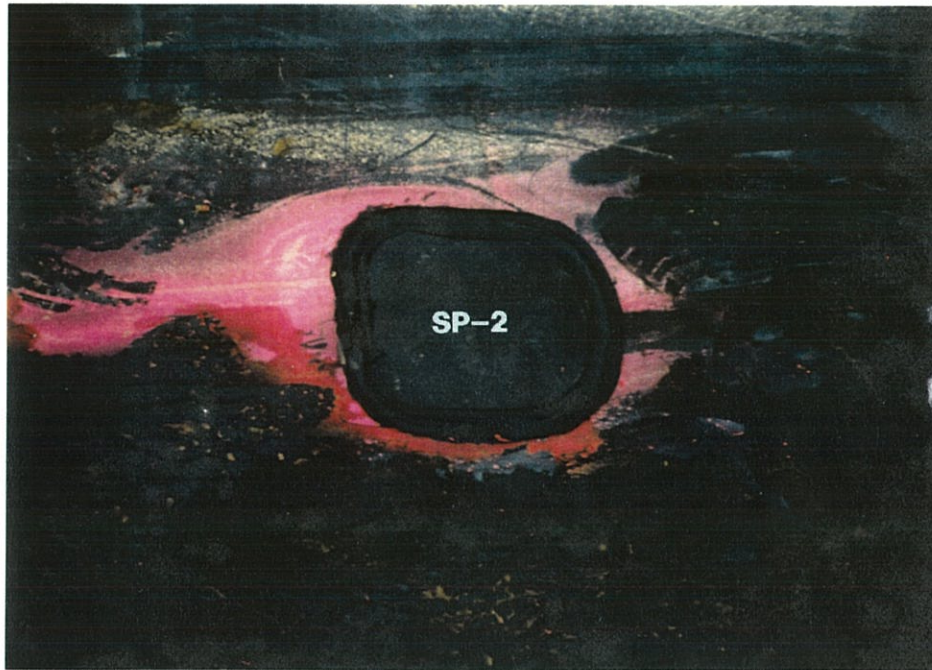
Photograph 5 October 9, 1995  
Location: Surge Pond Liner-Repair  
Description: Repaired Puncture SP-2

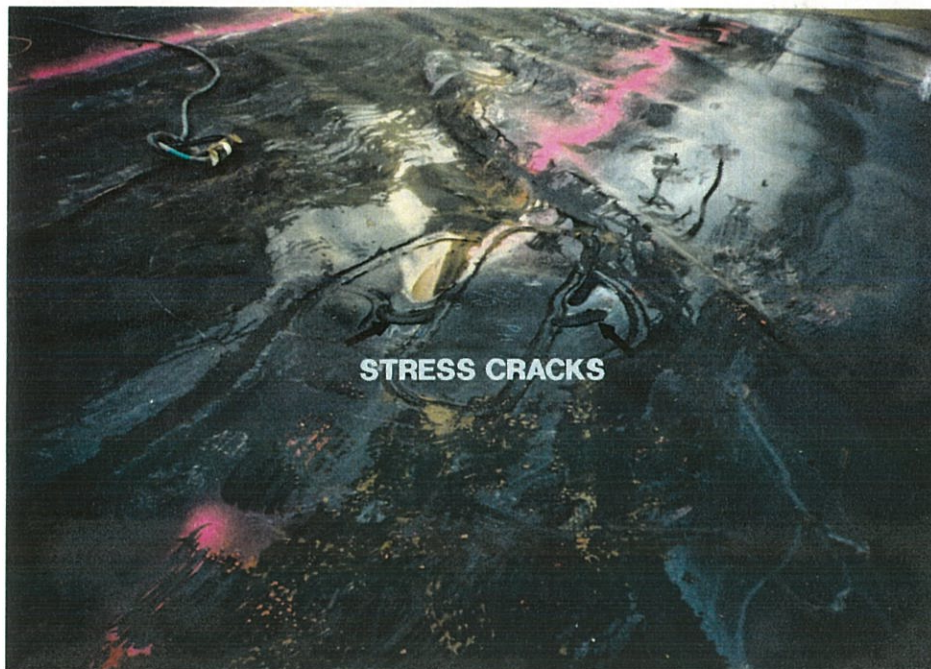
Photograph 6 October 9, 1995  
Location: Surge Pond Liner-Repair  
Description: Extrusion repair of stress cracks at pond influent pipes. Note: Stress cracks were observed during the repair of SP-1 and SP-2.
