**Construction Documentation Report**

**Type I Settling Ponds Liner Construction**

**Flambeau Mining Company  
Ladysmith, Wisconsin**

**December 1995**

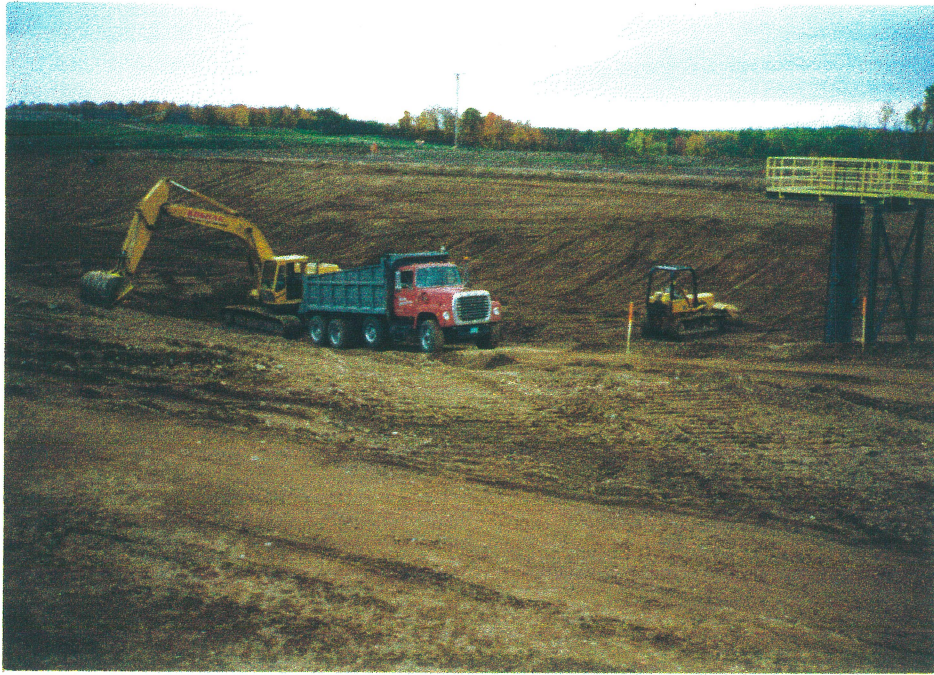
Photograph 1 October 4, 1995  
Location: North Pond  
Description: Removal of vegetation.

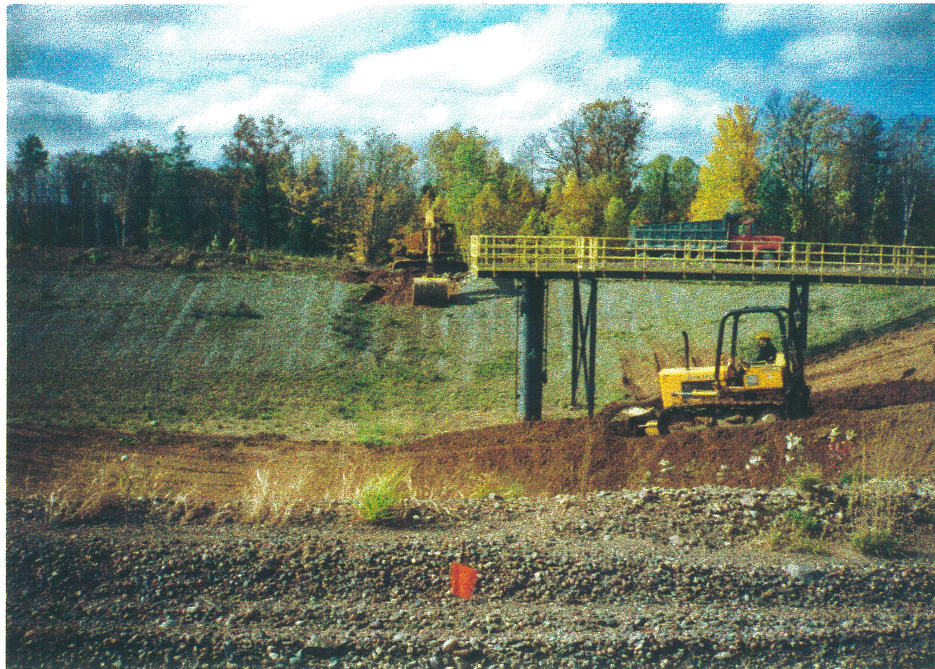
Photograph 2 October 5, 1995  
Location: South Pond  
Description: Removal of Rip-Rap and vegetation.

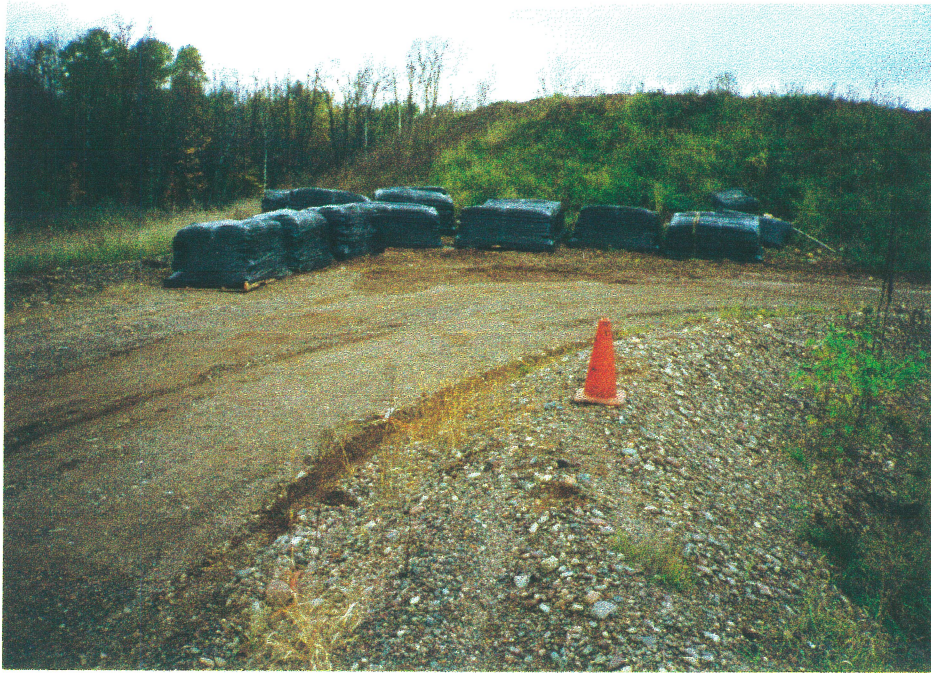
Photograph 3

Description: Pallets of PVC liner.

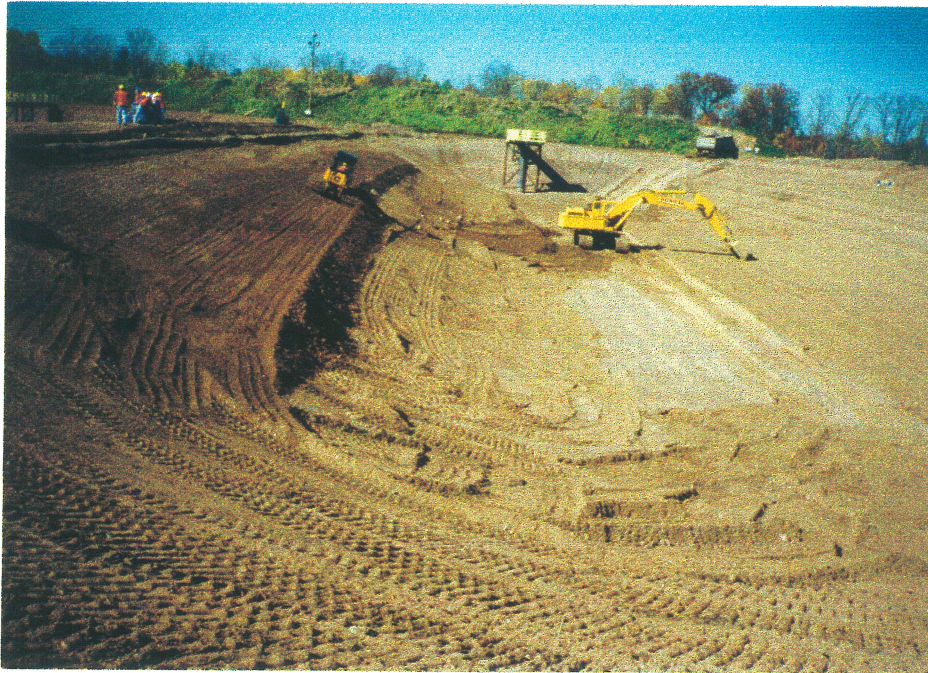
Photograph 4

Description: Fine grading south berm.

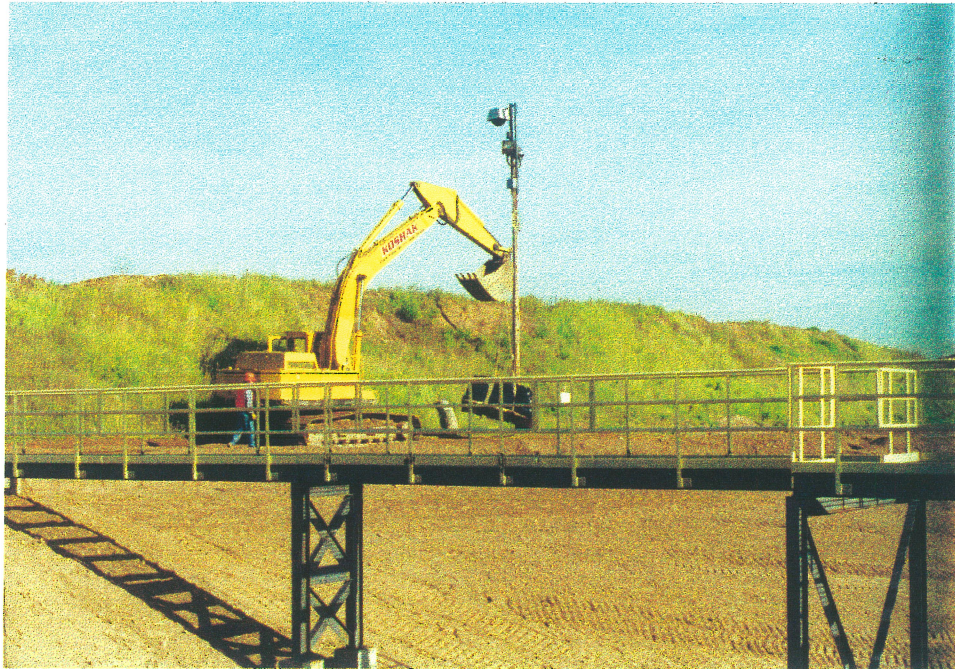
Photograph 5

Description: Distribution of PVC pallets.

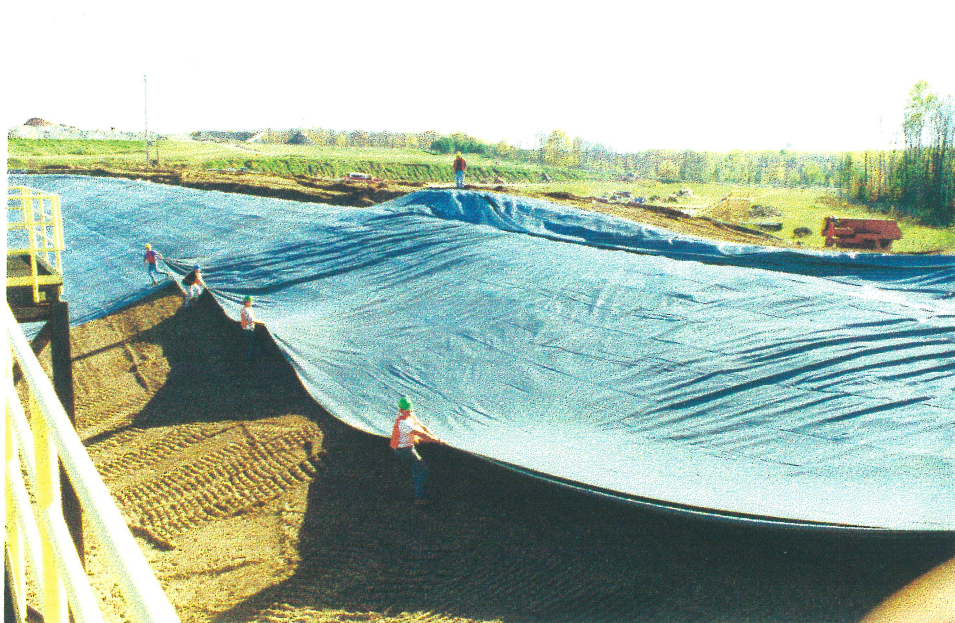
Photograph 6

The deployment crew (consisting of 8 to 10 personnel spread along the length of the panel) picked up the upper layer of the panel and unfolded it as they proceeded down the sideslope to the center of the pond (Photograph #6, Appendix C). The panels final location was then adjusted to maintain the proper minimum panel lap to allow seaming to the adjacent panel. Panel Placement Summary is found in Appendix D.

Description: Deployment of PVC Panel No. 1 (B-6).

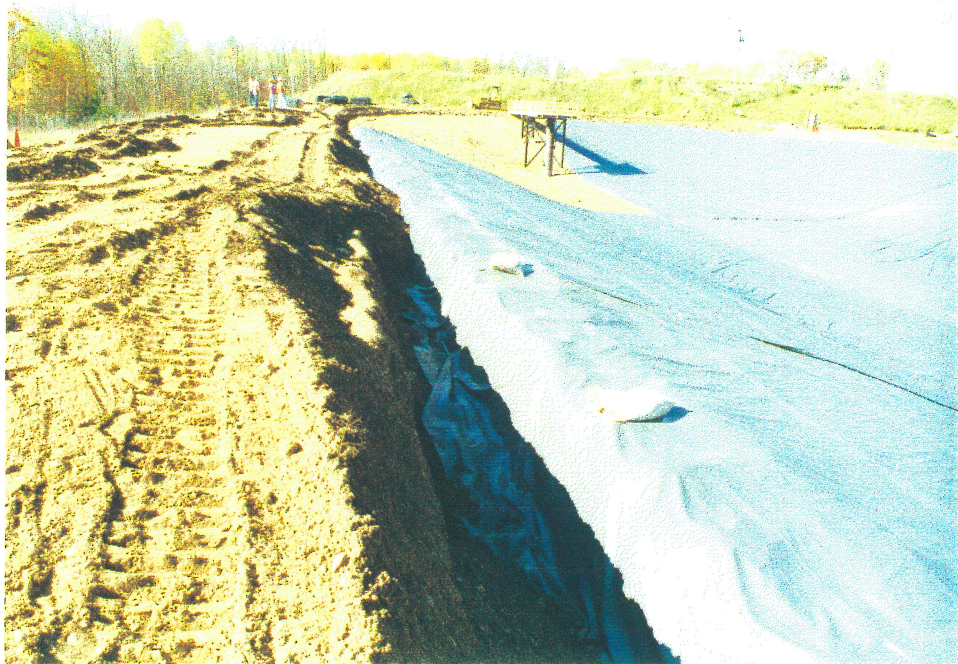
Photograph 7 October 11, 1995  
Location: South Pond  
Description: Partially backfilled anchor trench of south berm.

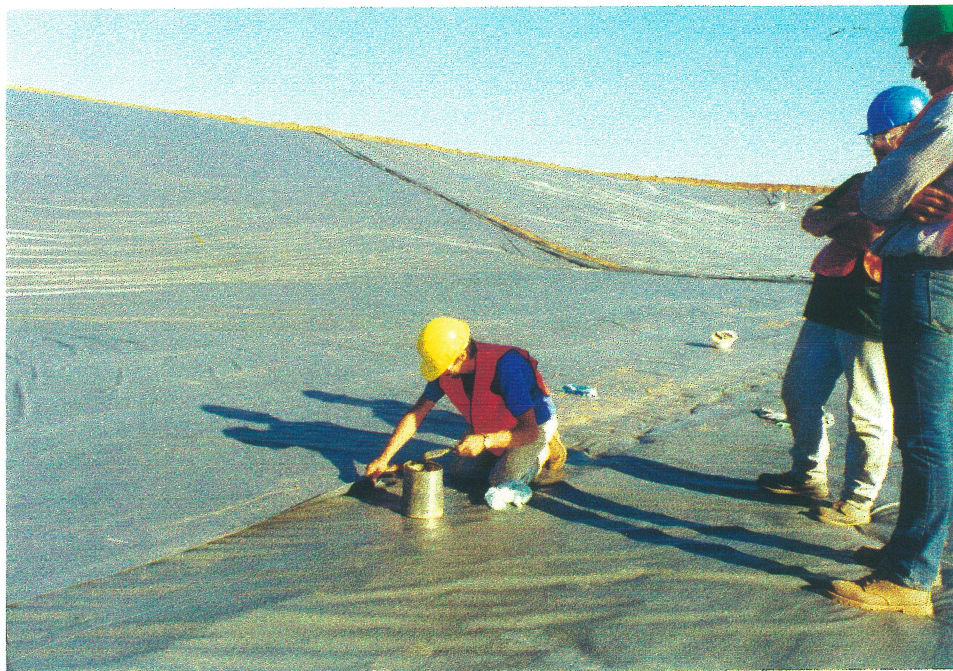
Photograph 8 October 11, 1995  
Location: South Pond  
Description: Solvent welding seam.

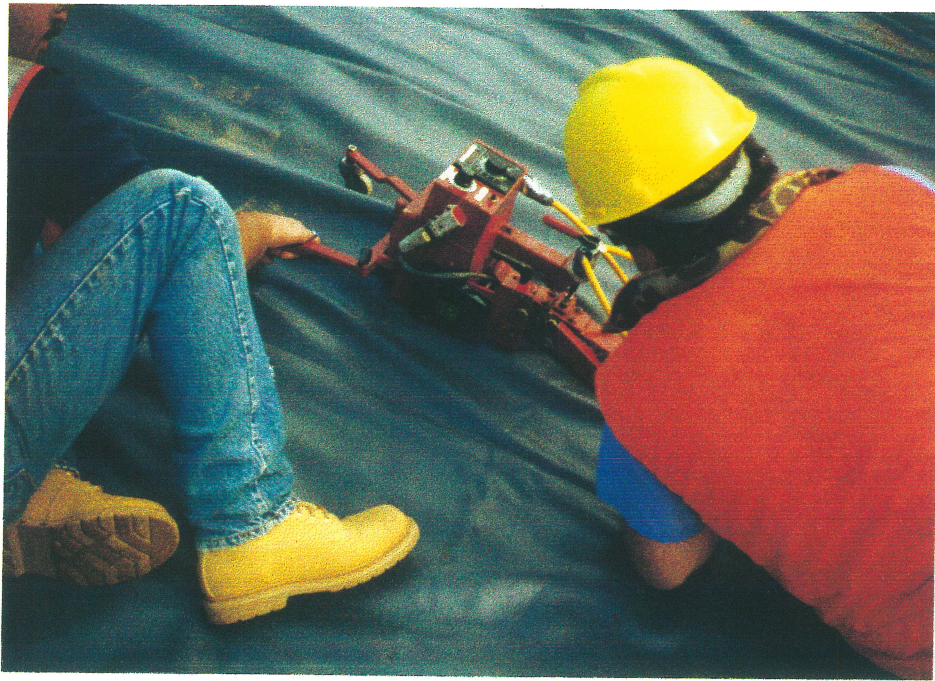
Photograph 9

The hot wedge heats the liner surface to a molten state in front of the drive rollers which compress the molten surfaces together forming one or two welded seams. The unwelded area between the seams forms an air space which can be pressurized to test for leaks. The speed setting and temperature of the welding unit were monitored during welding operations to document that the machine settings were not changed from those used to prepare the test seams. Photograph #9 illustrates the use of a hot wedge welding machine.

Description: Double wedge welding seam.

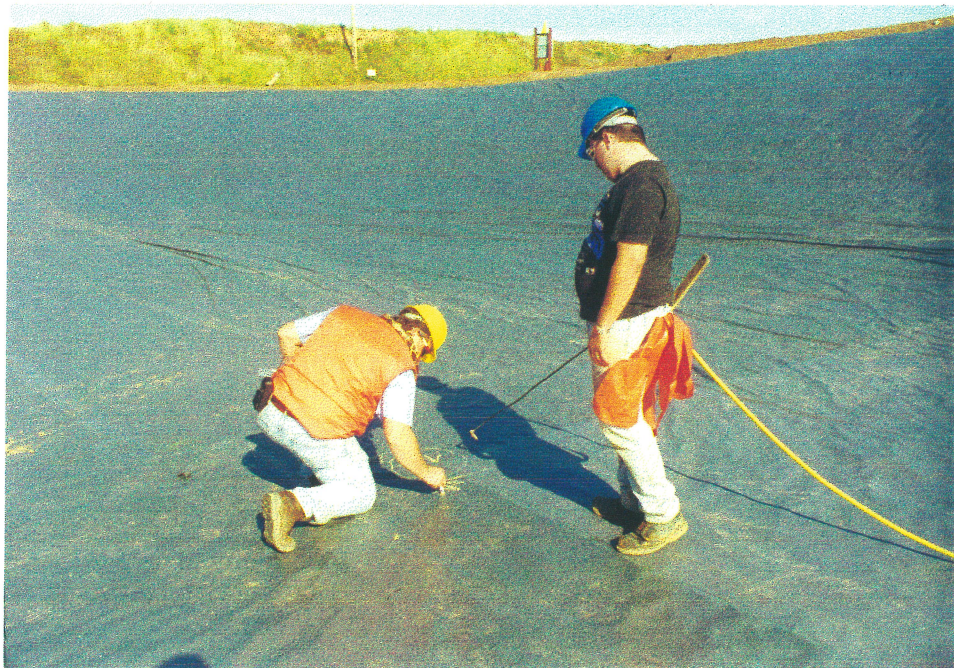
Photograph 10

If the air lance test indicated a discontinuous seam, the seam was repaired and the seam retested. For seams that could not be repaired by using solvent and applying pressure, the defective area was cut out and a solvent welded patch applied over the cut-out area. The perimeter of the welded seam was tested by using the air lance. Photograph #10 in Appendix C shows the non-destructive testing procedure.

Description: Air lance testing seam.

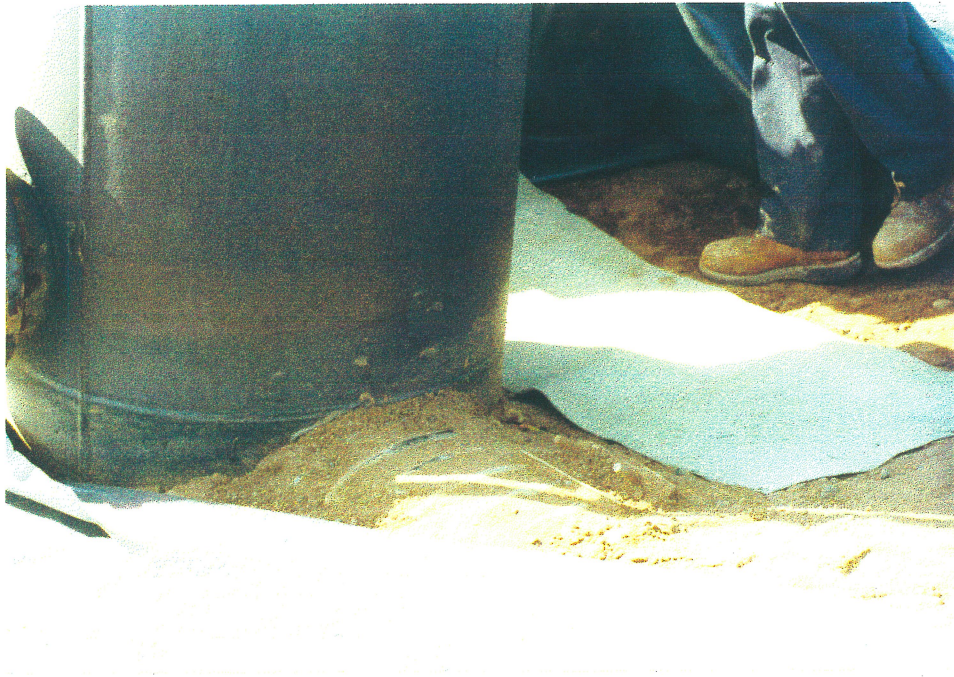
Photograph 11

Description: Placing GCL below PVC liner around control structure.

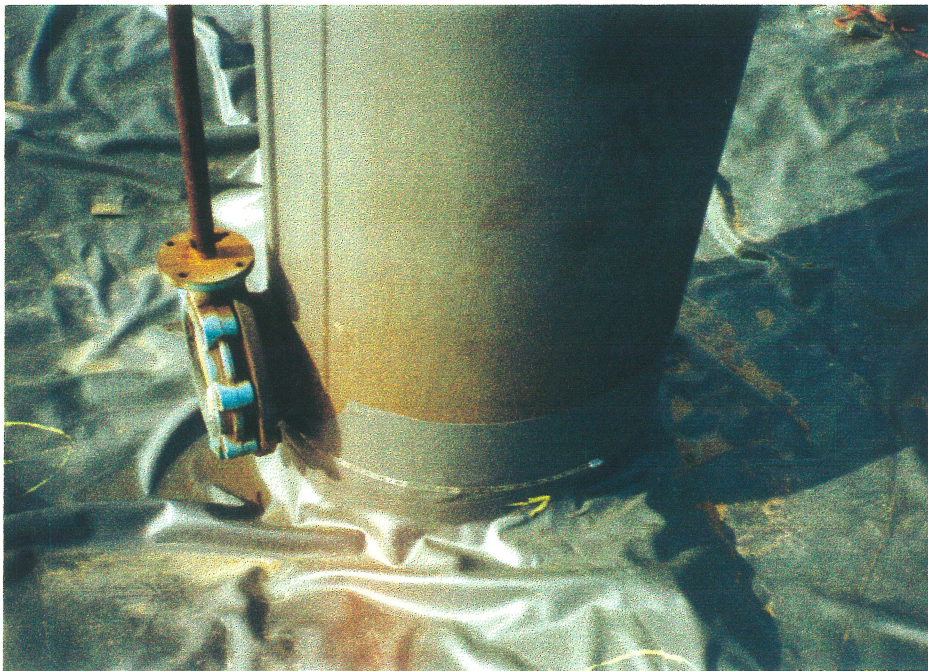
Photograph 12

The PVC boot was field constructed around the control structure and a stainless steel band installed and tightened to seal the PVC to the steel pipe (Photograph #12).

Description: PVC boot strap around control structure. Note location of seam voids from air lance tests which were repaired.

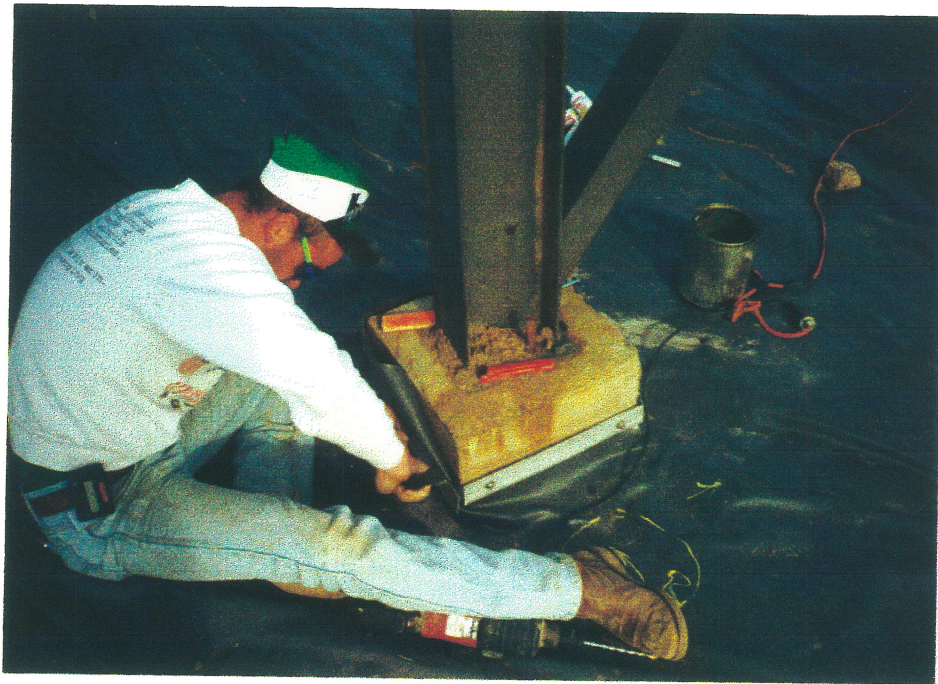
Photograph 13

A PVC boot was field fabricated for each pier and abutment. The liner was attached to each pier as illustrated by the Liner Attachment Details for Bridge Piers found in Appendix H (Photograph #13, Appendix C). The boot was attached to the bridge abutment as illustrated by the Bridge Abutment Detail.

Description: Anchoring PVC liner to concrete piers.
