TO: Dave Cline, Flambeau Mining Company
Leland Roberts, Flambeau Mining Company
CC: Steve Donohue, Foth Infrastructure & Environment, LLC
Foth Project #: 17F777.19
FR: Sharon Kozicki, Foth Infrastructure & Environment, LLC
Steve Lehrke, Foth Infrastructure & Environment, LLC
Allison Haus, Foth Infrastructure & Environment, LLC
RE: 2018 Annual Summary Memorandum – Reclaimed Flambeau Mine
Flambeau Mining Company

This 2018 Annual Summary Memorandum documents the work that was completed by Flambeau Mining Company (Flambeau) at the Reclaimed Flambeau Mine Site, Ladysmith, Wisconsin, in 2018, to satisfy the requirements of the Mining Permit (MP). These requirements are summarized in Table 1.

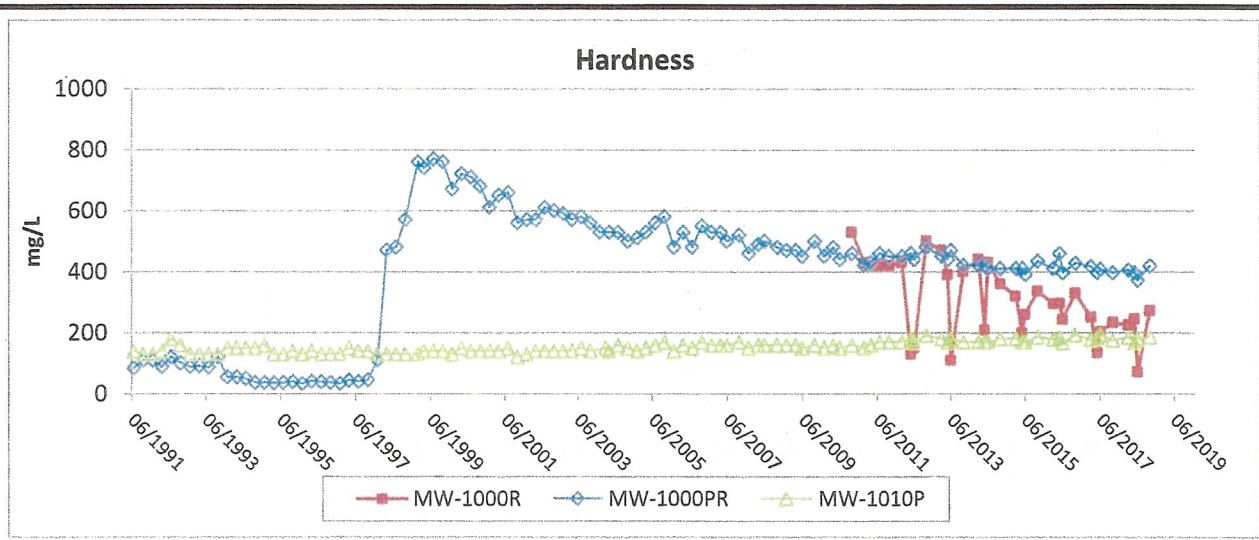
<small>F O T H CONSULTING SERVICES, INC.</small>		
FLAMBEAU MINING COMPANY		
Figure B-1b		
Groundwater Trend Graphs - Quarterly Results		
MW-1000R/MW-1000PR/MW-1010P		
Scale: NA	Date: January 2019	
Prepared By: SGL	Checked By: SVF	Project: 17F777.18

Note: Iron trend graphs are displayed on a logarithmic scale so the trend patterns of MW-1000R, MW-1000PR and MW-1010P are visible at different concentration scales.

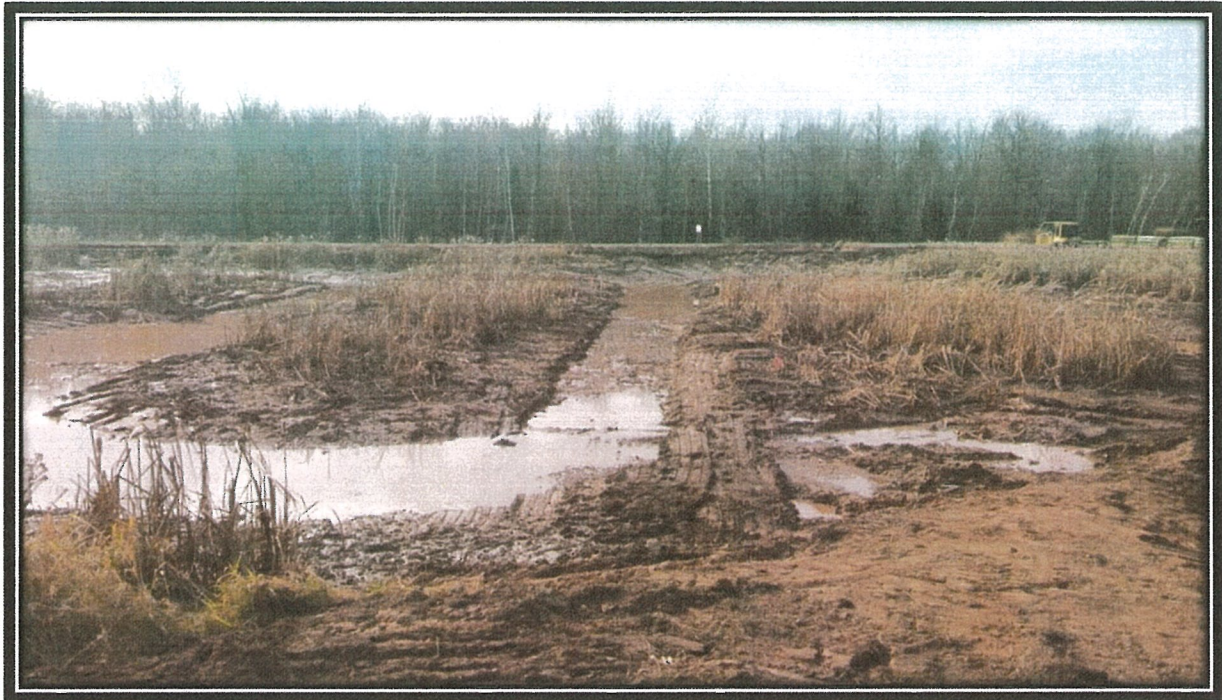
The low flow channel construction was completed in fall 2015 (Photographs 1 & 2). Both the naturalized low flow channel and the bottom areas were vegetated by September 2016 (Photographs 3 & 6). Native and non-native species cover increased from 2017 through August 29, 2018 (Photographs 4, 5, 7 & 8). A total of 46 plant species were observed in the emergent area in 2018 (Appendix 1 Table 2). Of the seven emergent species seeded from Table 1, three were observed and of the sixteen wet prairie species seeded from Table 2, twelve species were observed with an additional 25 native volunteer species. Typical species observed included; water plantain (*Alisma subcordatum*), blunt spikerush (*Eleocharis obtusa*), rice cut grass (*Leersia oryzoides*), arrowhead (*Sagittaria latifolia*) and cattails (*Typha* spp.) The vegetation areal coverage was estimated at 121% with native species comprising 110% of the total areal cover.

Photograph 1. East Area naturalized low flow channel with side tapering on November 11, 2015.

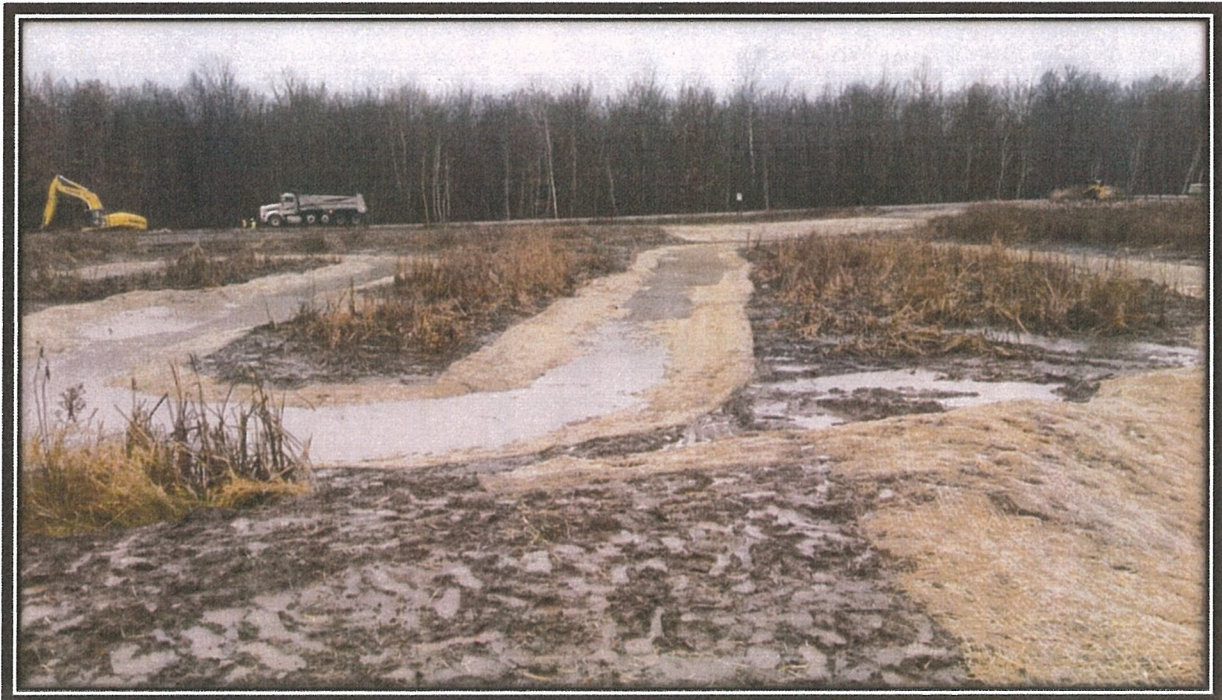
Photograph 2. East Area naturalized low flow channel with erosion blanket on November 17, 2015.

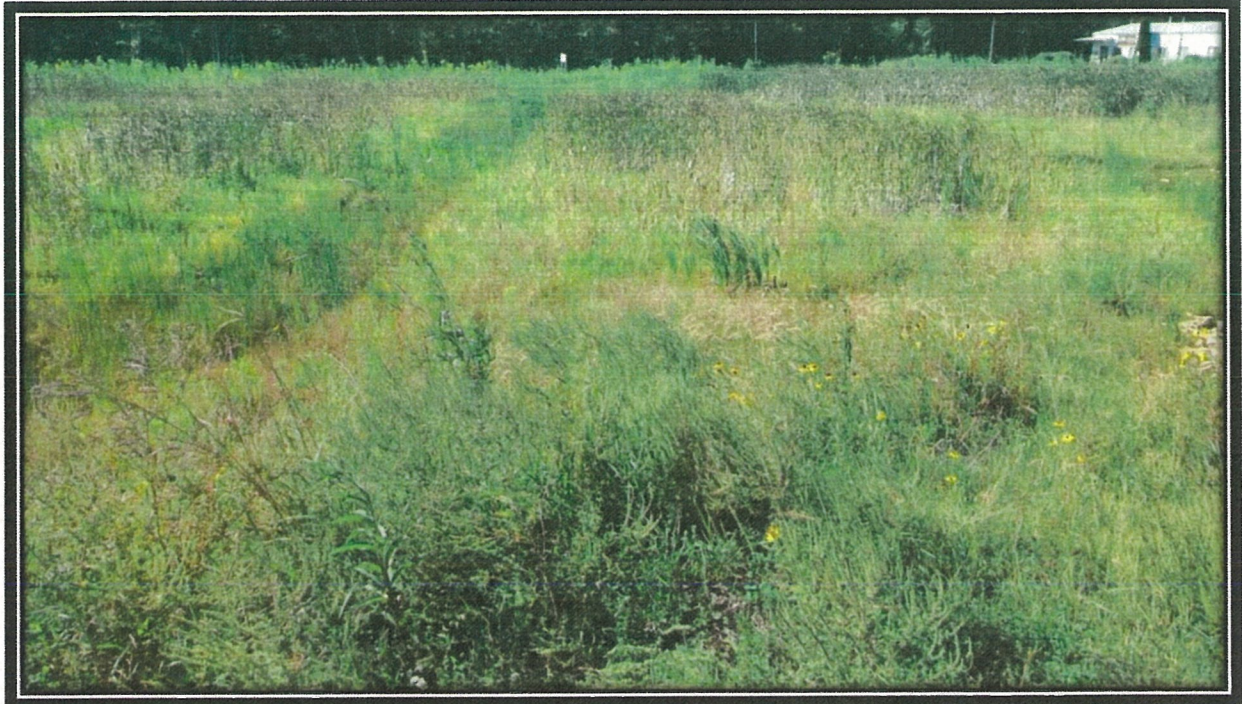
Photograph 3. Vegetated naturalized low flow channel (dark green strip) and wet meadow with cattails in East Area, taken on September 8, 2016.

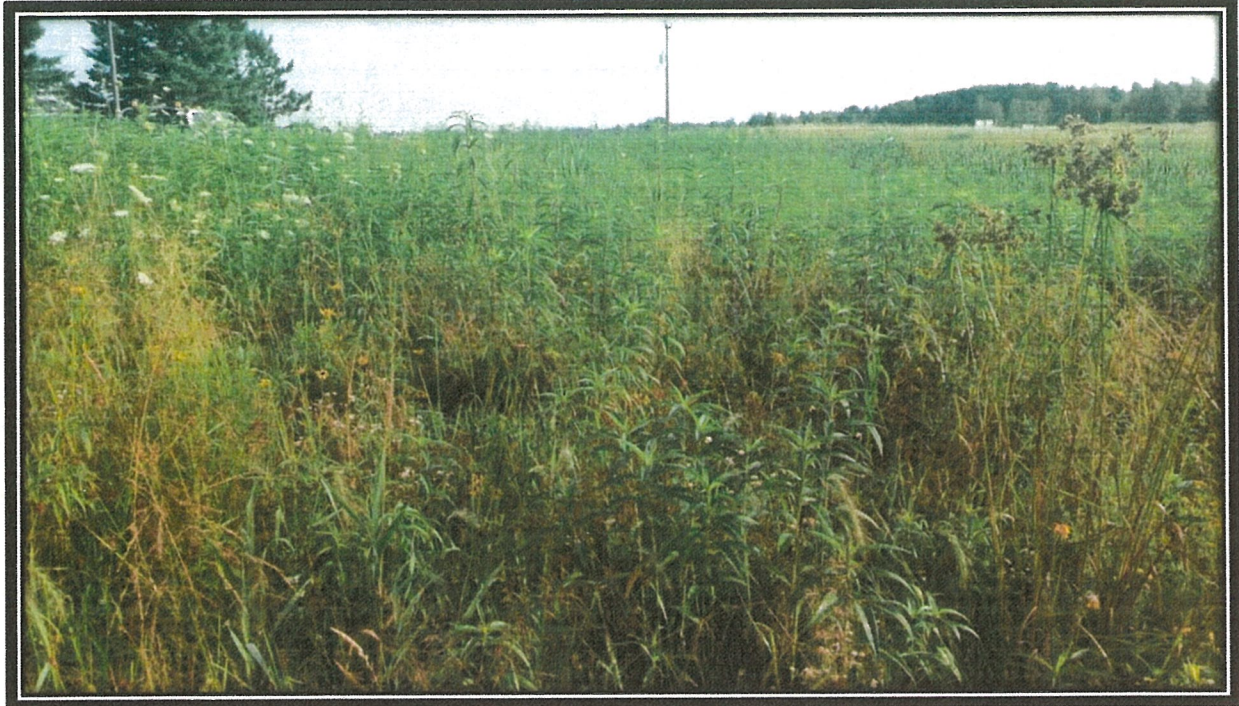
The East Area side slopes had been restored to upland prairie (Photographs 9 & 10). Of the 12 upland prairie species seeded on side slopes, nine were observed in August 2018 (Appendix 1, Table 1). Overall vegetation cover was estimated at 96% with native species comprising 65% of the cover. The upland slopes contained individuals of black-eyed Susan (*Rudbeckia hirta*), yellow coneflower (*Ratibida pinnata*) and Canada wild rye (*Elymus canadensis*), beardtongue (*Penstemon digitalis*), bergamot (*Monarda fistulosa*), stiff goldenrod (*Solidago rigida*), switch grass (*Panicum virgatum*), big bluestem grass (*Andropogon gerardii*) and Indian grass (*Sorghastrum nutans*) with varying areal coverage.

Photograph 9. East Area prairie slope dominated by saw tooth sunflower, taken on August 9, 2017.

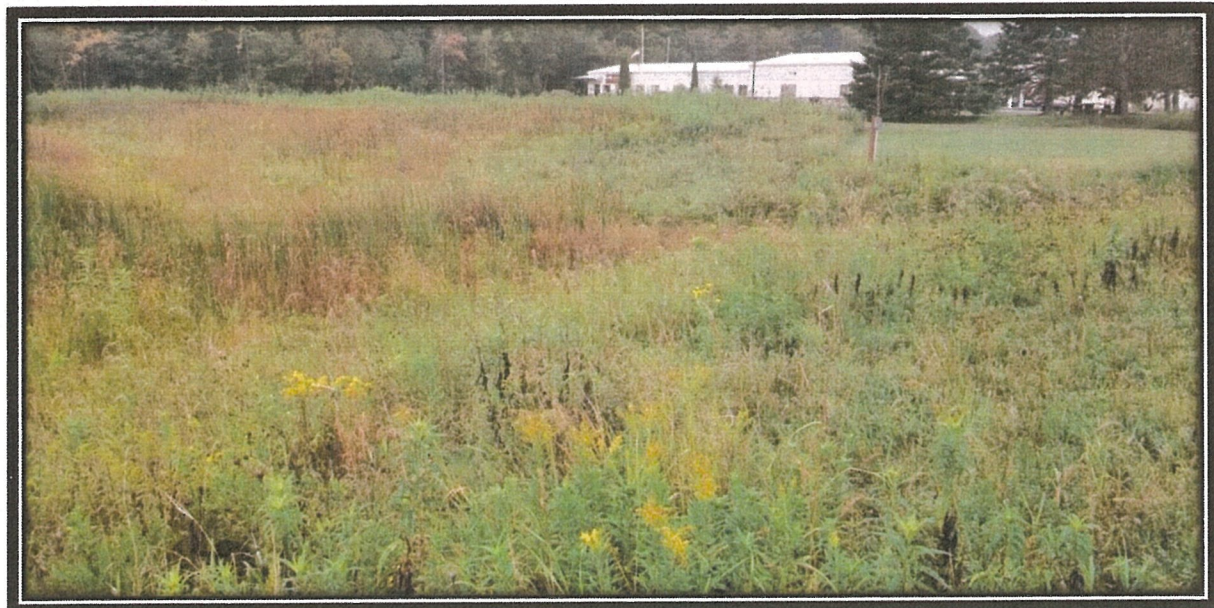
Photograph 10. Recently seeded upland prairie (foreground) on the East Area buffer slope, taken on August 29, 2018.

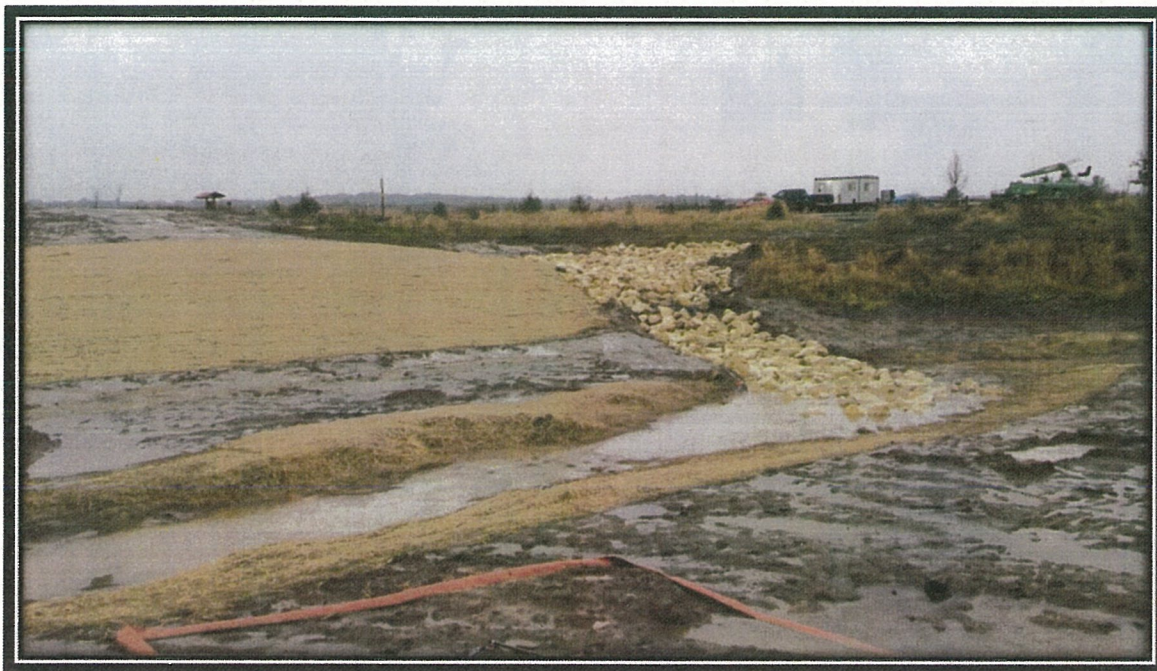
A rock-lined surface water inlet was installed in the northwest corner of the North Area as an erosion control measure (Photograph 21). The upland slope near the inlet was seeded with an upland native mix (Table 3). Seedling germination was evident by June 2016 and the area was well vegetated by September 2016 and continued through August 29, 2018 (Photographs 22-24).

Photograph 21. Surface water inlet in the northwestern corner of North Area with rock rip rap and side slope with erosion blanket in November, 2015.

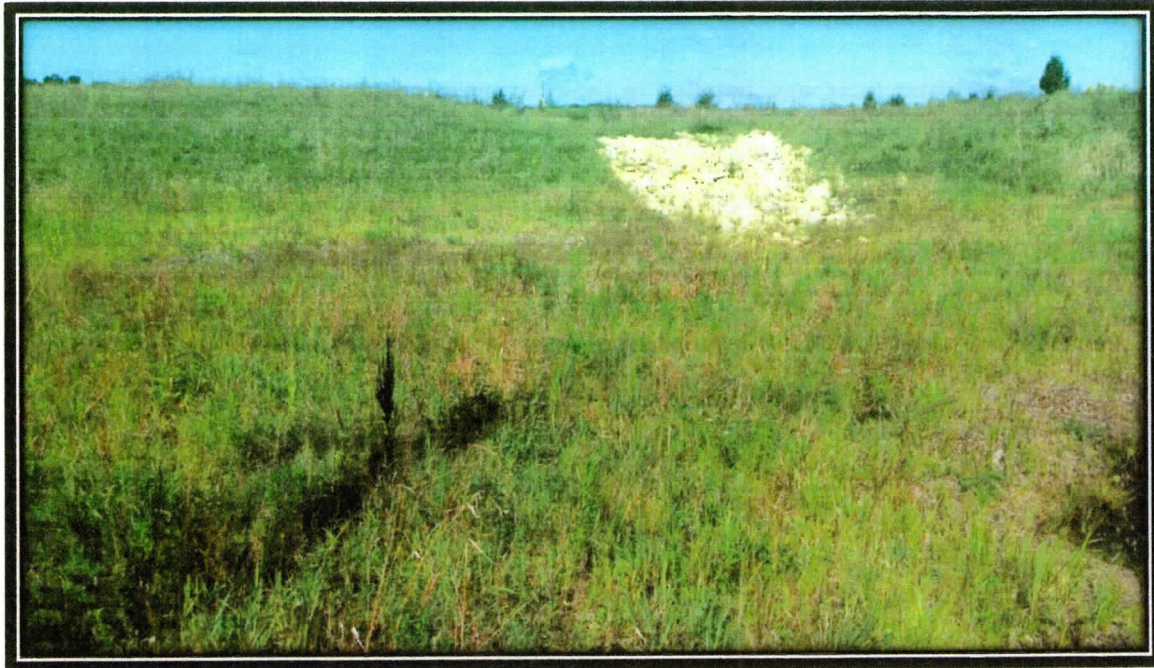
Photograph 22. Surface water inlet in the northwestern corner of North Area, with side slope stabilized on September 8, 2016.

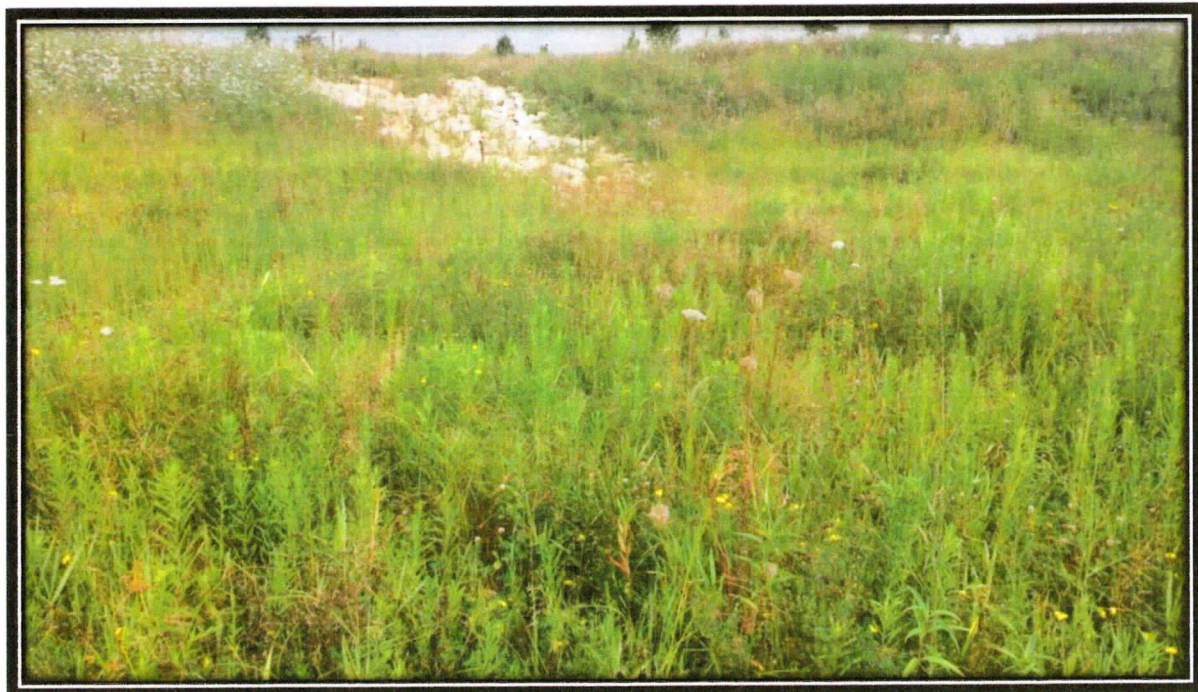
Photograph 23. Surface water inlet in the northwestern corner of North Area with rock rip rap, August 9, 2017.

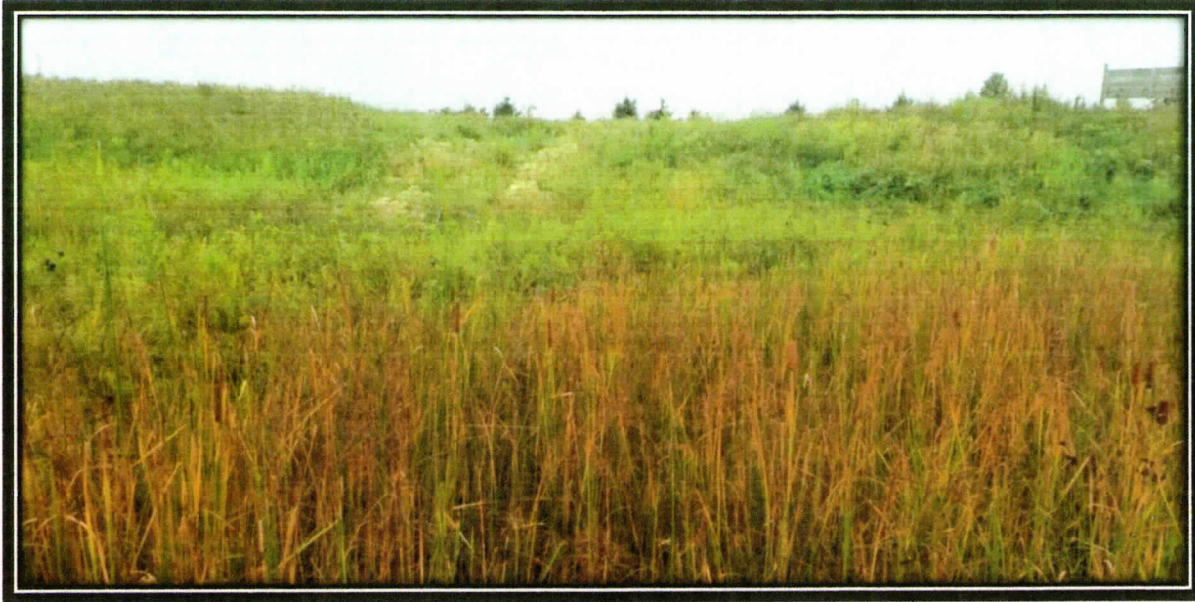
Photograph 24. Surface water inlet in the northwestern corner of North Area with rock rip rap on August 29, 2018.

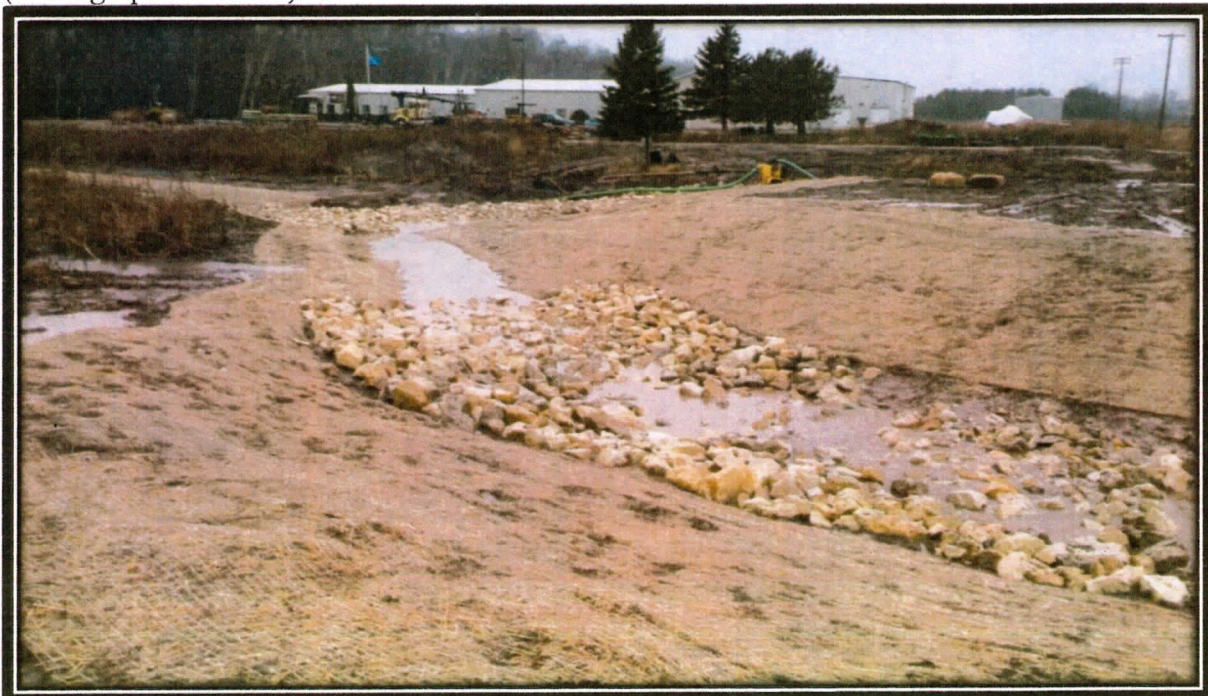
A rock-lined swale connection between the North and East Areas was completed in November 2015 (Photograph 25). Seed germination along the slopes of this swale connection was observable in June 2016 and the swale and upland prairie side slope were fully vegetated by August 29, 2018 (Photographs 26 & 27).

Photograph 25. North and East Area rock-lined swale connection completed and slopes blanketed on November 17, 2015.

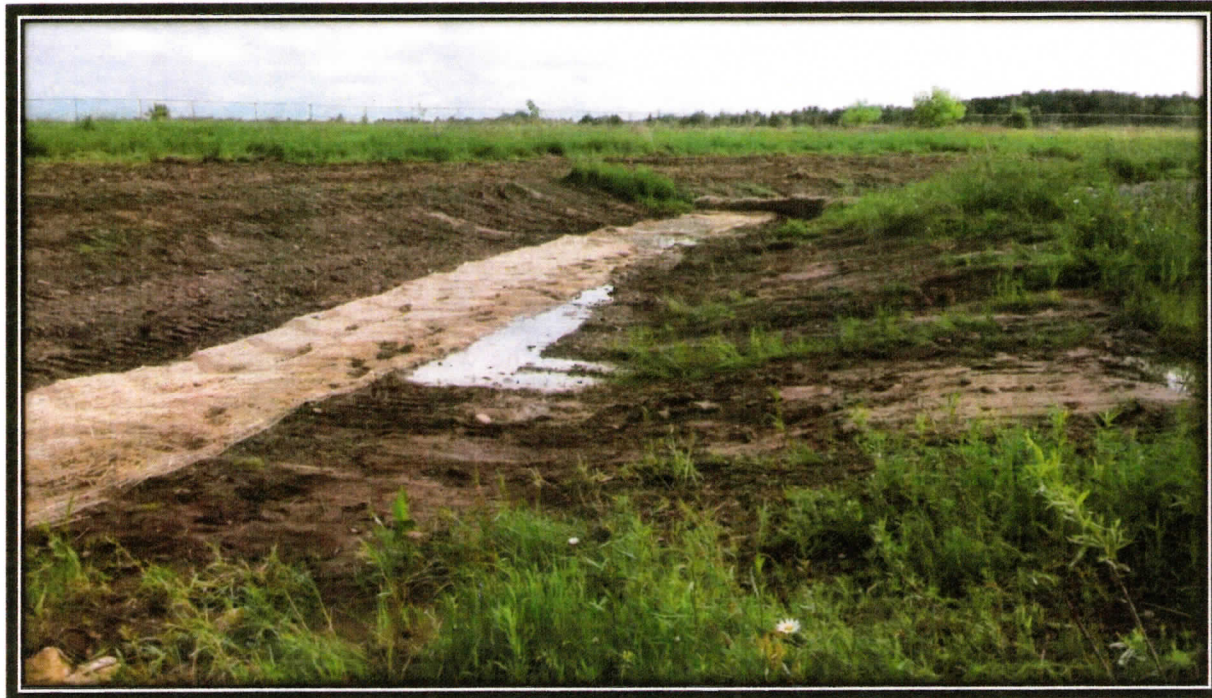
Photograph 28. East-West Swale final shaping and erosion control blanket in place along the swale on June 16, 2016.

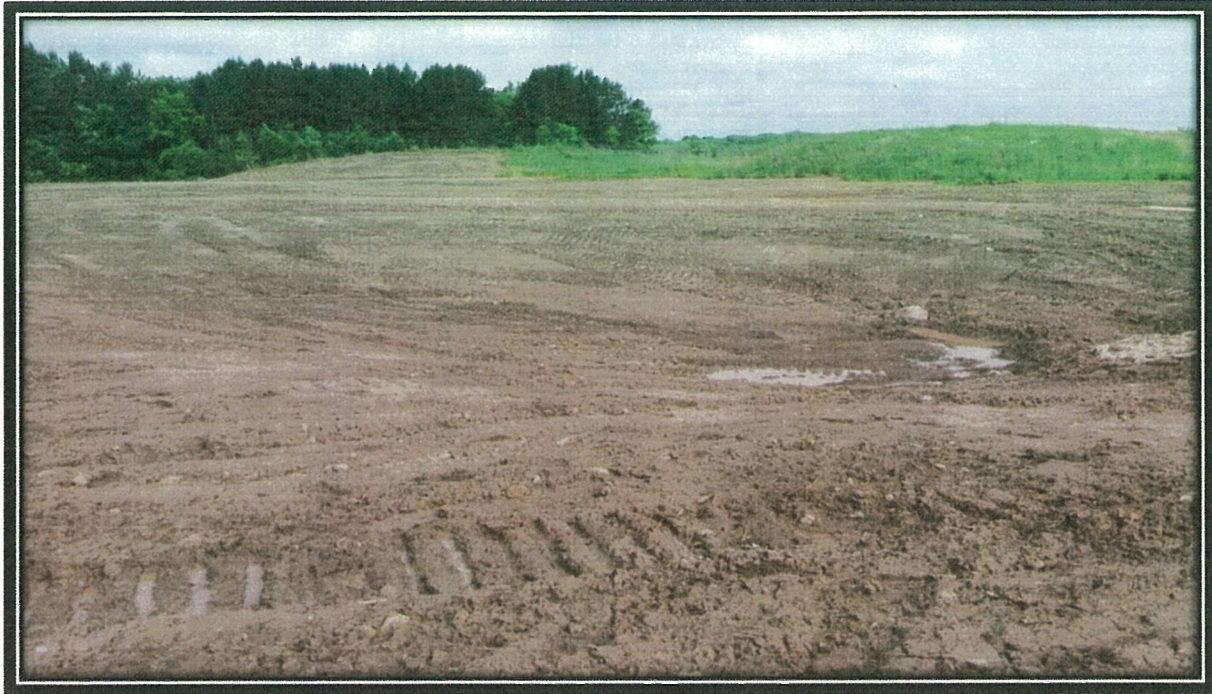
The West Area (Figure 1) final grading was completed in 2016 (Photograph 34) after which areas were seeded with native species (Tables 1-3). The upland prairie vegetative cover (excluding open water ponds) exceeded 100% in the West Area by August 2018 (Photograph 35 and Appendix 1, Table 6). Of the seven emergent species seeded in the West Area, three species were observed in August 2018 and 11 of the seeded wet prairie species were observed (Appendix 1, Table 6). Eight of the seeded upland prairie species were observed. A variety of native wetland species have established around the shoreline of the three emergent zones and in the upland prairie (Photograph 36-41). Typical wetland species included water plantain, dark green bulrush and cattail with typical upland species being Canada wild rye and switch grass.

Photograph 34. Final grading of the West Area on June 16, 2016.

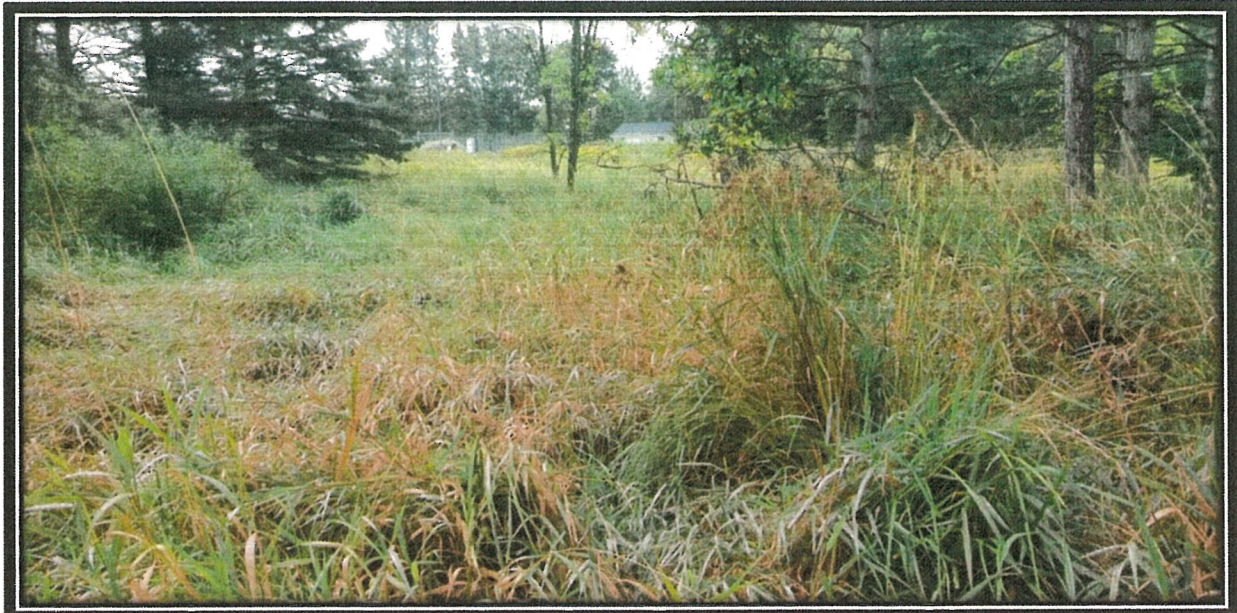
The upland buffer for Wetland 7 continues to contain a variety of non-native weeds and a few native upland species such as black-eyed Susan, yellow cone flower and switch grass. Several non-native species; burdock (*Arctium minus*), Canada thistle (*Cirsium arvense*) and reed canary grass were present.

Photograph 43. Wetland 7 with a dominance of reed canary grass and some native species on August 29, 2018.
