## OPERATING IDEAS

### Rock Bolting at the Flambeau Open-Pit Mine

By Raymond Yost

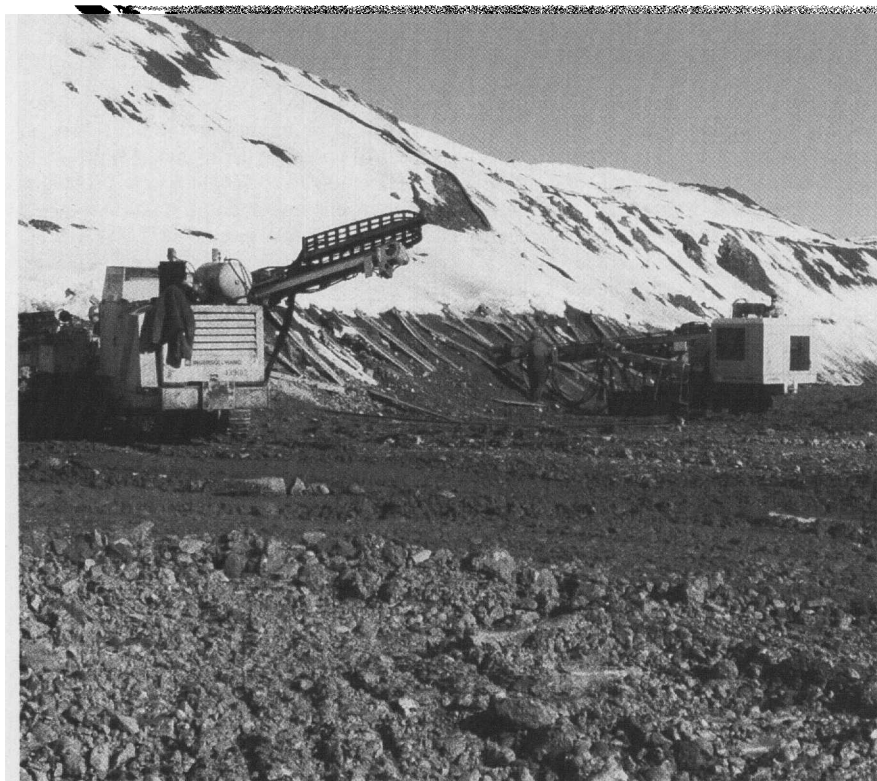
Ingersoll Rand drills were used to install the bolts throughout the pit.

The bolts were installed with an Ingersoll Rand LM 500 drill, but several modifications were necessary to optimize the drill performance. The first change was

made for safety. The drill controls were moved from the mast to the main body of the drill to reduce the highwall exposure to the operator. A rod changer was also added so that one person could operate the drill without the need for a helper.

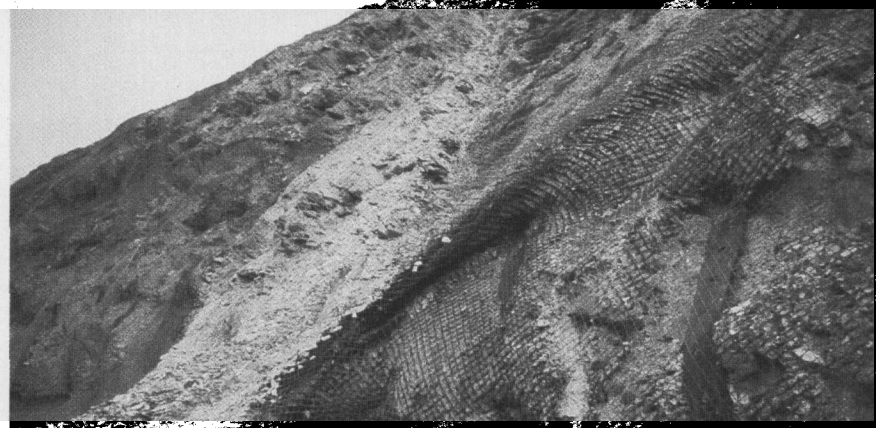
Area where mesh washers failed, allowing accumulated debris to fall onto bench. The majority of such failures occurred where no straps were installed.

The second problem did not become evident until several months after the bolts and mesh had been installed. During the spring thaw, the rate of near-surface rock breaking accelerated dramatically and loaded the mesh with loose material. In areas where the mesh was fastened to the front of the bolt plate with a special mesh washer, the washer would break, allowing the mesh to pull away from the bolt and the accumulated debris to fall onto the benches below. A number of bolts had been installed with the mesh fastened in front of the bolt plate to secure the bolt to the uneven face of the slope as tightly as possible rather than installing the mesh behind the bolt plate, which often resulted in a gap of 15-30 cm between the slope and the bolt plate.

Both remediation of the affected area and a change in the mesh installation procedure were required to redress this problem. In areas where the mesh had begun pulling away from the bolts, a geofabric was installed to contain any secondary rockfall. To prevent any reoccurrence, the mesh was installed under the bolt plate and Ingersoll Rand Split Set friction stabilizers were used to anchor the chain link securely to the slope.

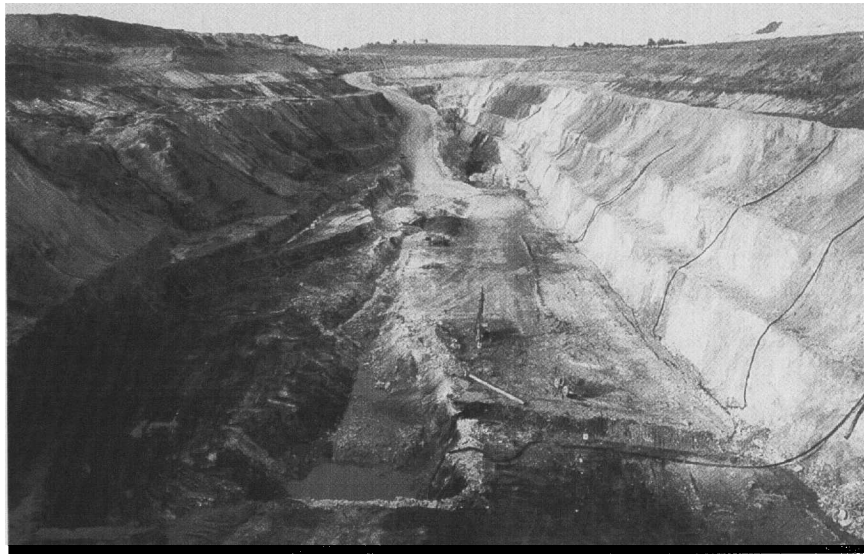
The Flambeau mine near Ladysmith, Wisc., looking northeast with the hanging wall to the left and the footwall to the right.
