# 1995 Annual Report

RE: Flambeau Mining Company - 1995 Annual Report

FLAMBEAU MINING COMPANY  
1995 ANNUAL REPORT

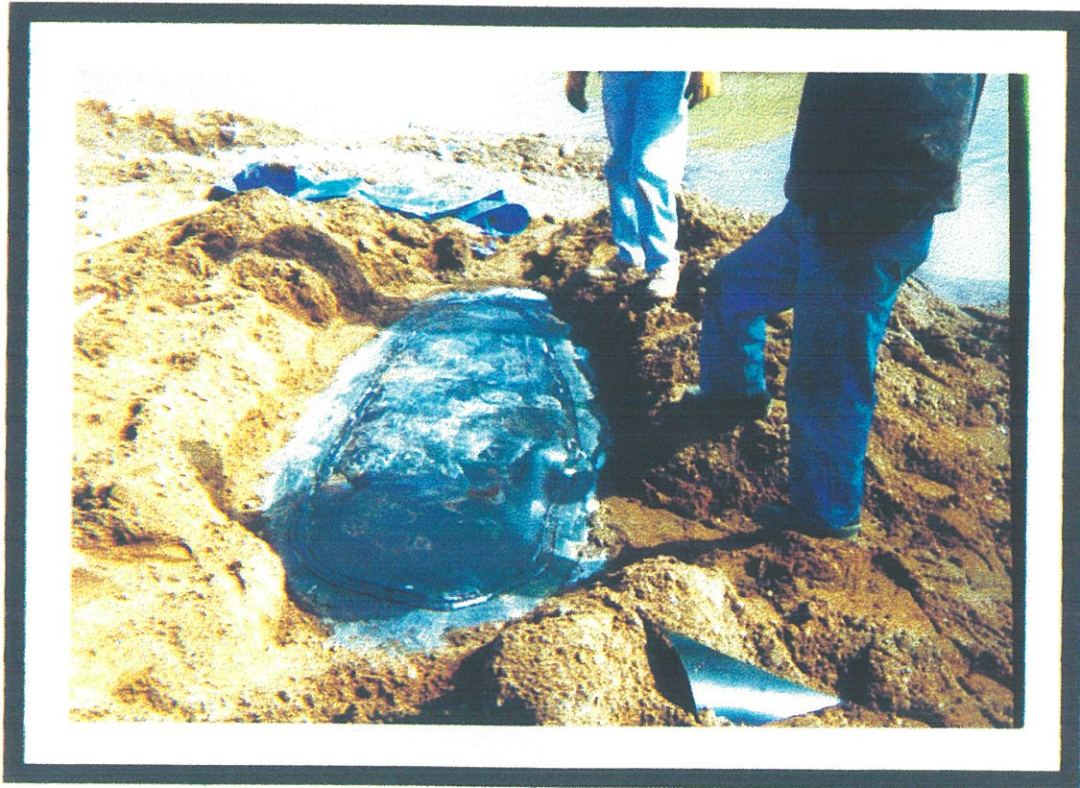
TYPE II STOCKPILE PHASE II LINER REPAIR  
MARCH 21, 1995
