# 1995 Annual Report

RE: Flambeau Mining Company - 1995 Annual Report

FLAMBEAU MINING COMPANY  
1995 ANNUAL REPORT

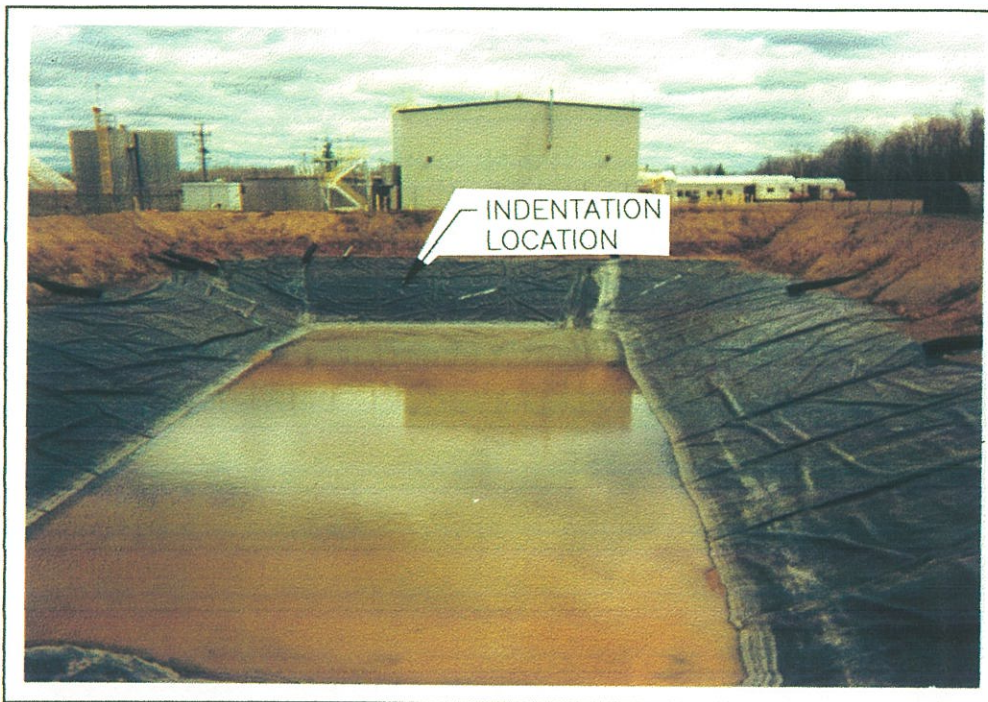
RUNOFF POND LINER INSPECTION  
APRIL, 1995
